# CITY OF PHILADELPHIA

# **PHILADELPHIA SCHOOL DISTRICT**

## **Follow-up Review of Conditions at School Buildings**

**September 2015**

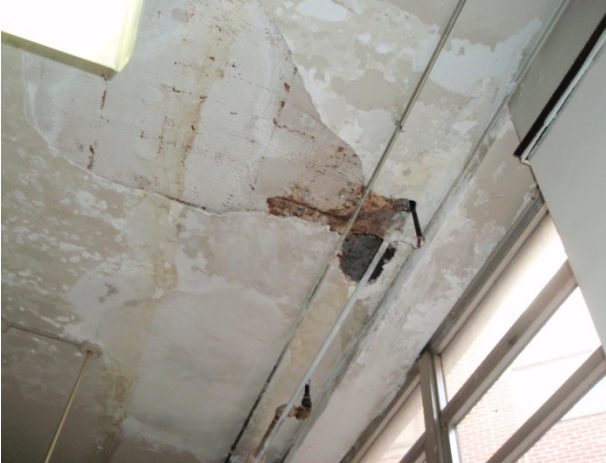
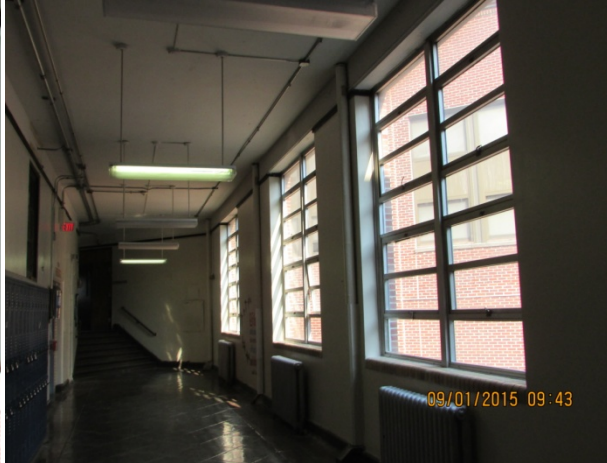
**Frankford High** - Before - Severely Damaged Plaster 2nd Floor Hallway. After - New plaster repairs and fresh paint throughout the school.

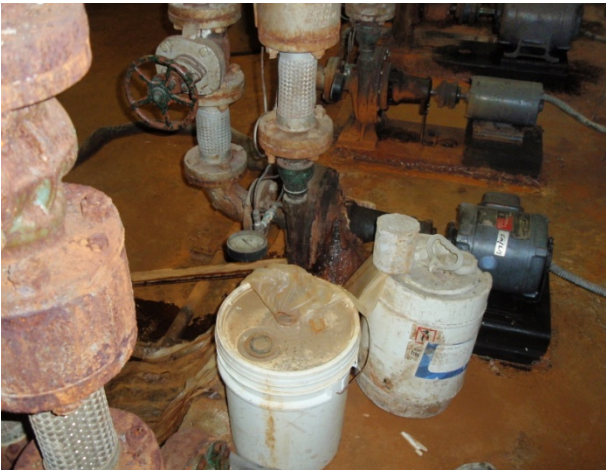
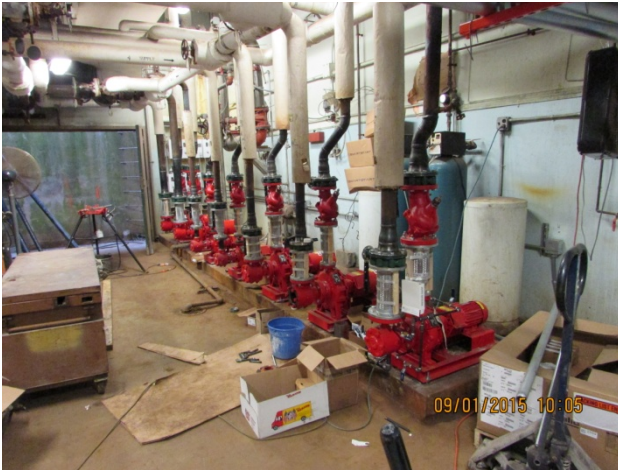
**Frankford High** - Before - Heating System circulator pumps leaking and bad bearings. After - All new circulating pumps and isolation valves installed on the heating system.

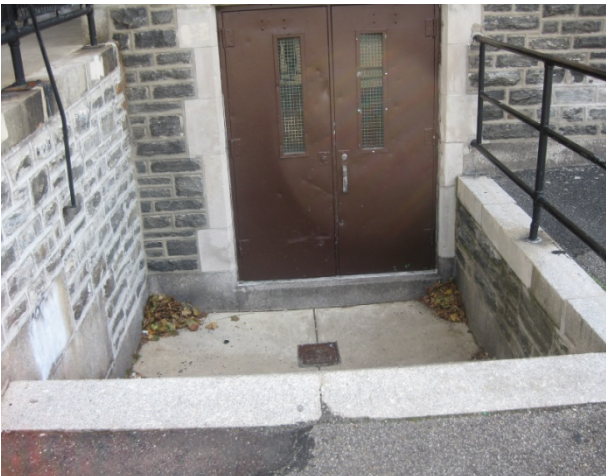
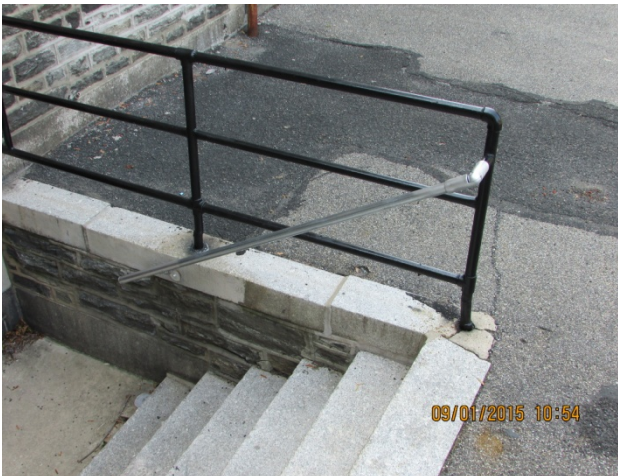
**Crossan Elementary** - Before - No railings in stairwells. After - New railings installed at all stairways.

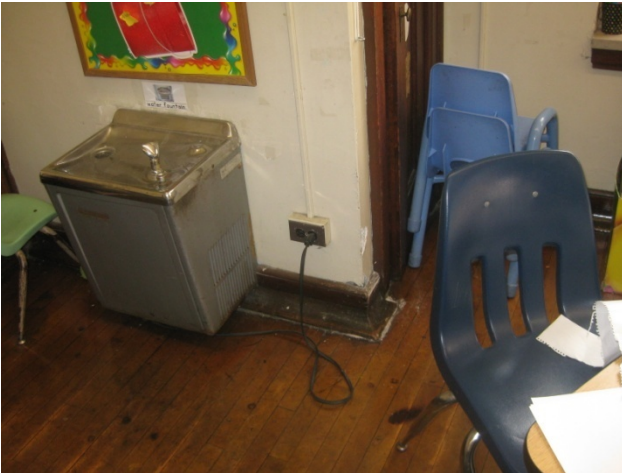
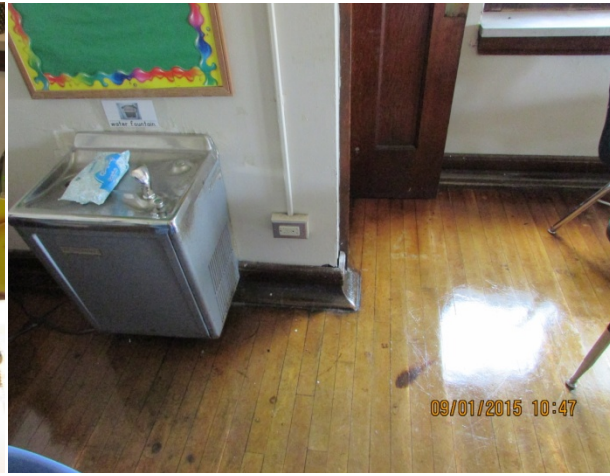
**Crossan Elementary** - Before - No GFCI next to a water fountain. After - New GFCI's installed throughout.

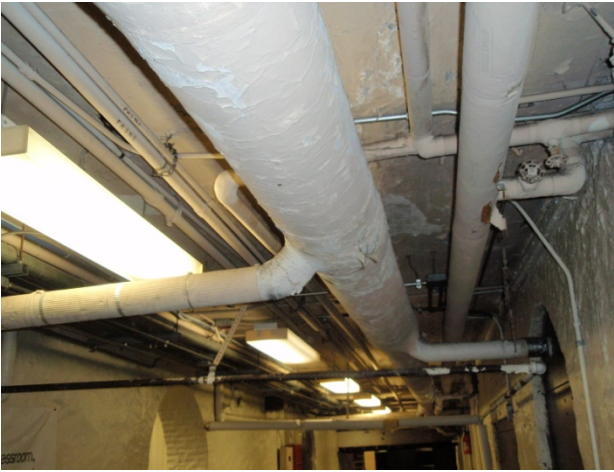
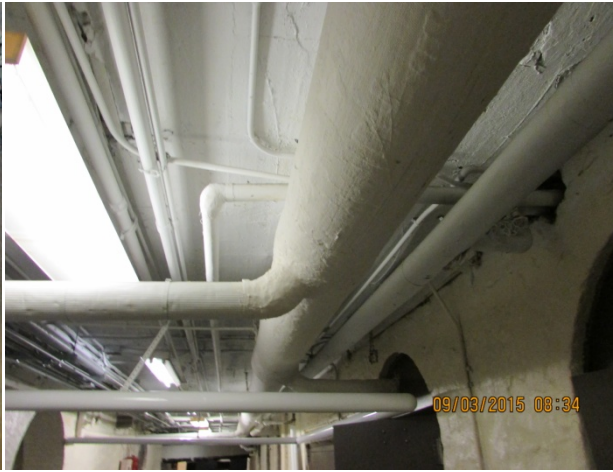
**Francis Scott Key Elementary** - Before - Asbestos wrapping in bad shape. After - Asbestos insulation encapsulated, properly sealed, plaster ceiling repaired and freshly painted.

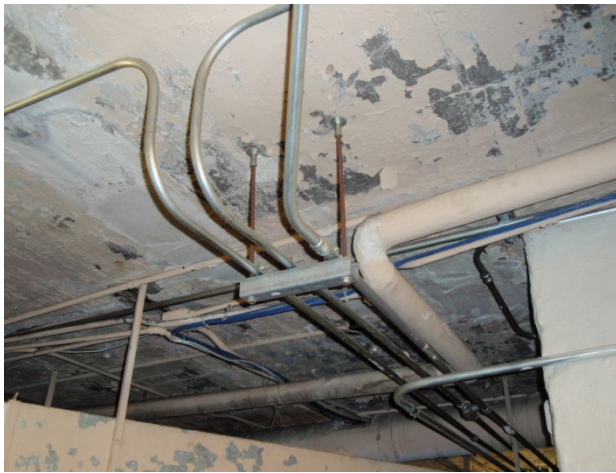
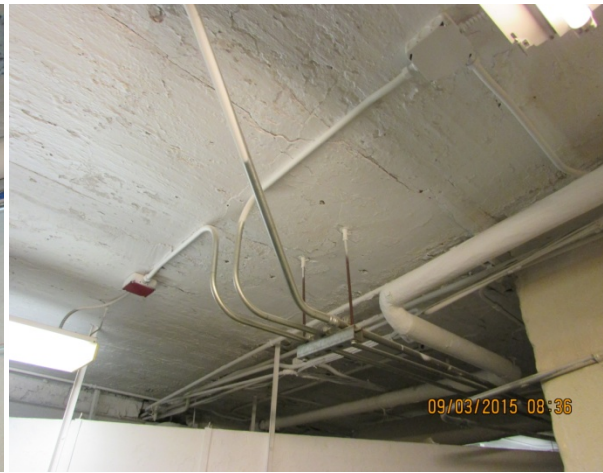
**Francis Scott Key Elementary** - Before - Flaking and peeling paint. After - Completely scraped and freshly painted.

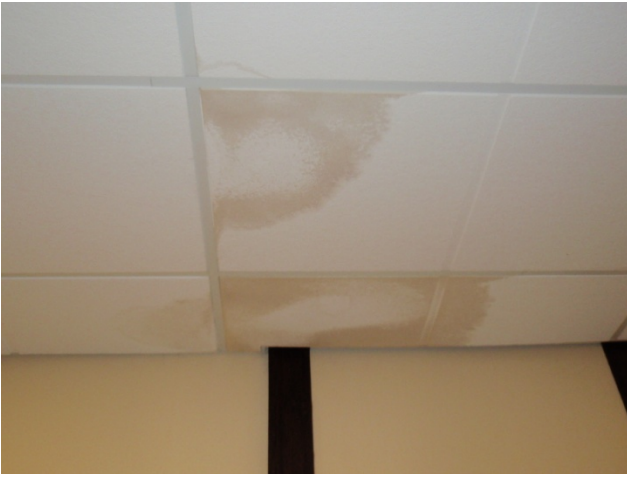
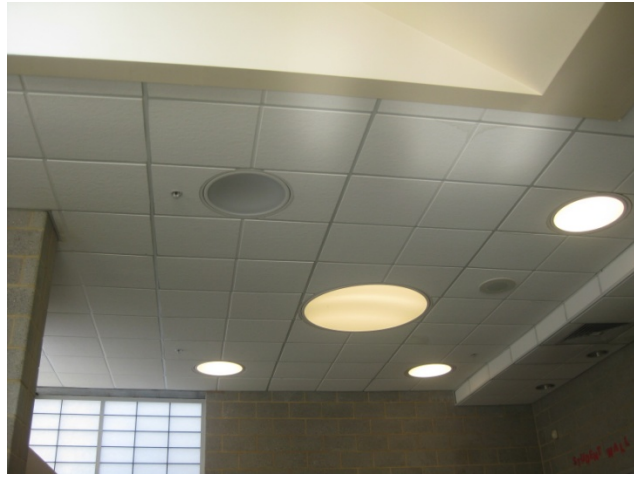
**Delaplaine McDaniel Elementary School** – Before - damaged ceiling tiles. After – Tiles were replaced.

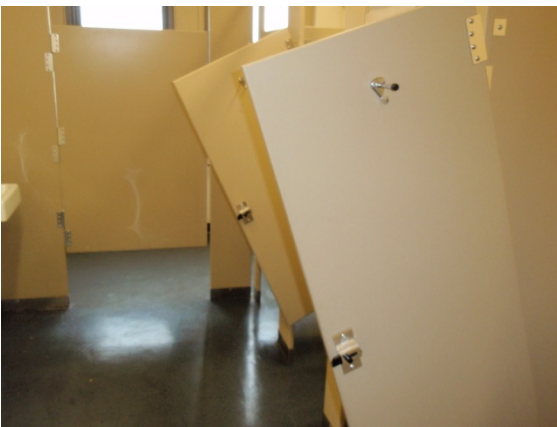
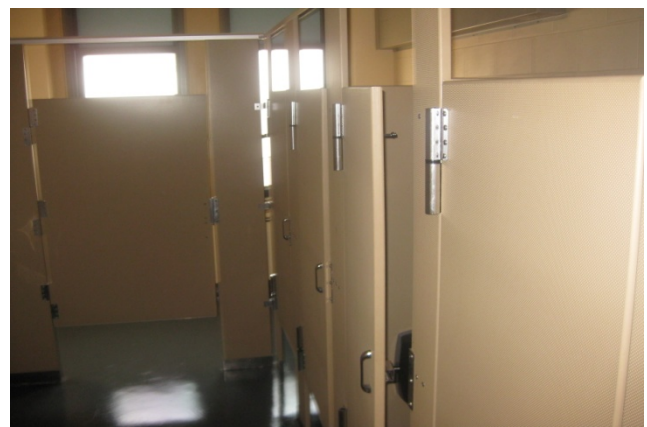
**Delaplaine McDaniel Elementary School** – Before - Broken stall doors in the girls room. After – Doors were repaired.

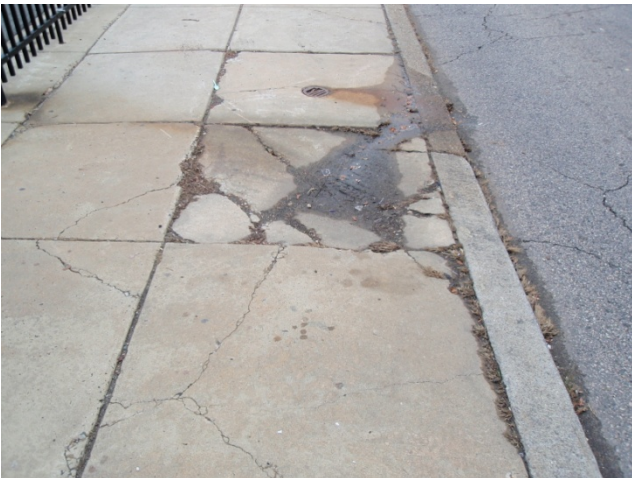
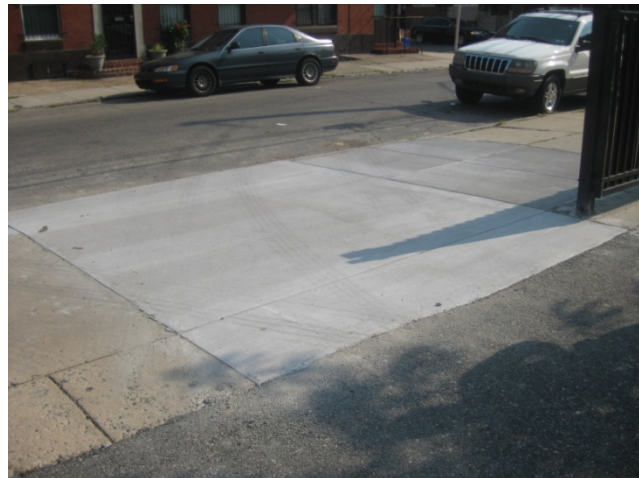
**Delaplaine McDaniel Elementary School** – Before - Damaged sidewalk. After – Sidewalk was patched.

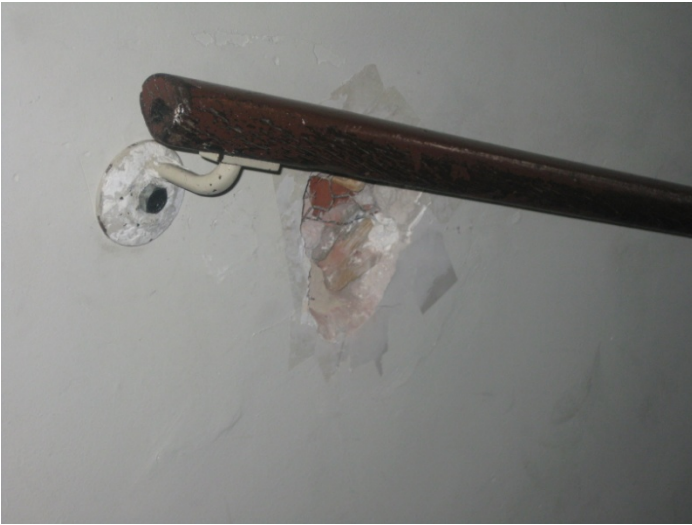
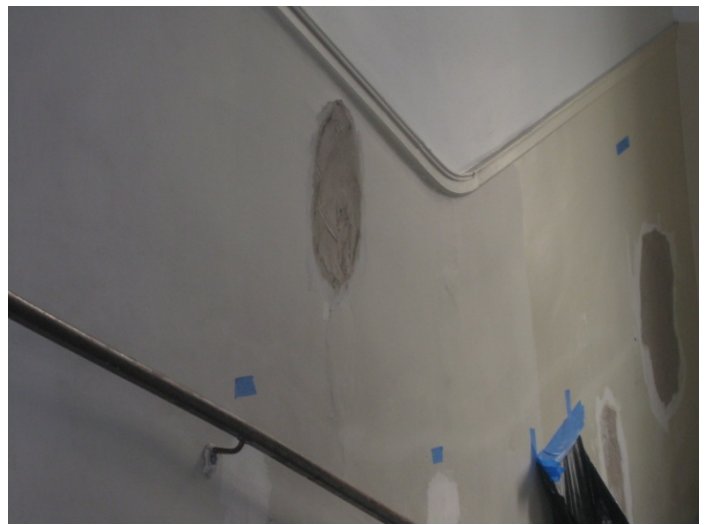
**Bayard Taylor Elementary School** – Before - Damaged plaster. After - Plaster work in progress.

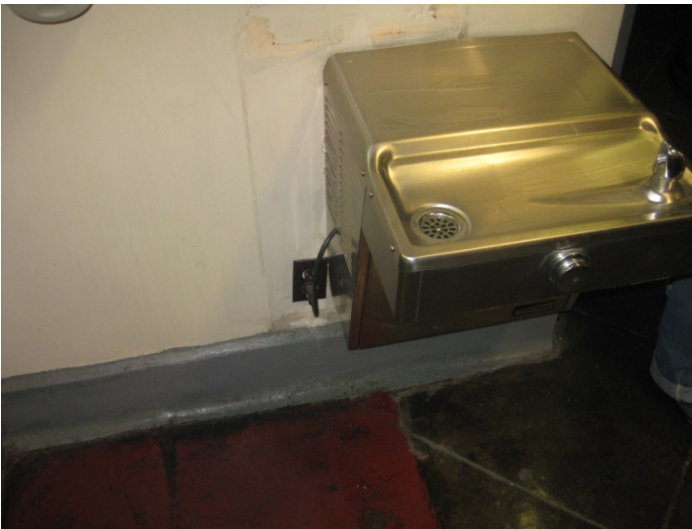
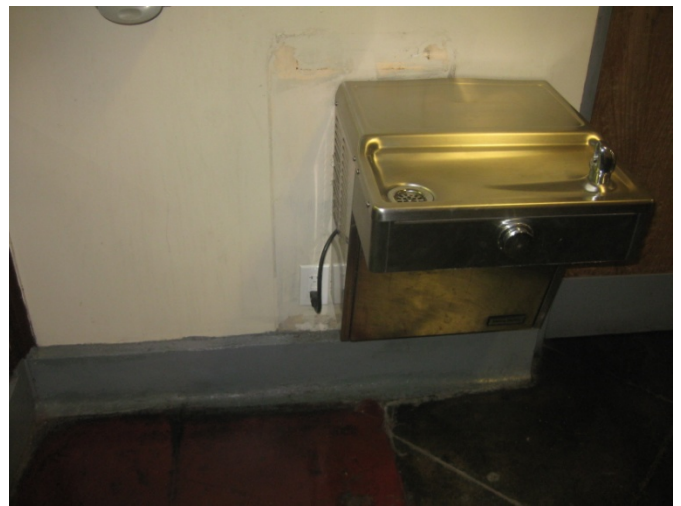
**Bayard Taylor Elementary School** – Before - Water fountain missing a GFCI outlet. After - GFCI outlet installed.

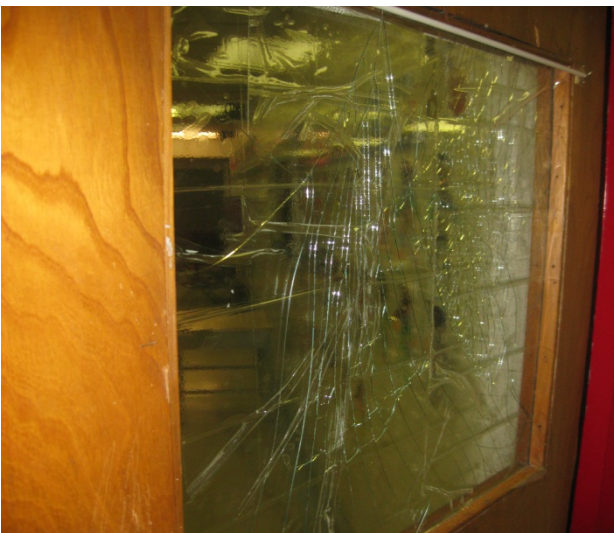
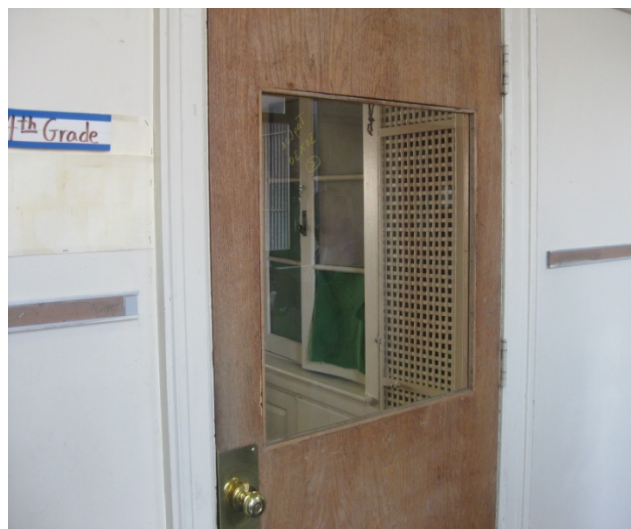
**Bayard Taylor Elementary School** – Before - Broken glass in a classroom door. After - Glass repaired.

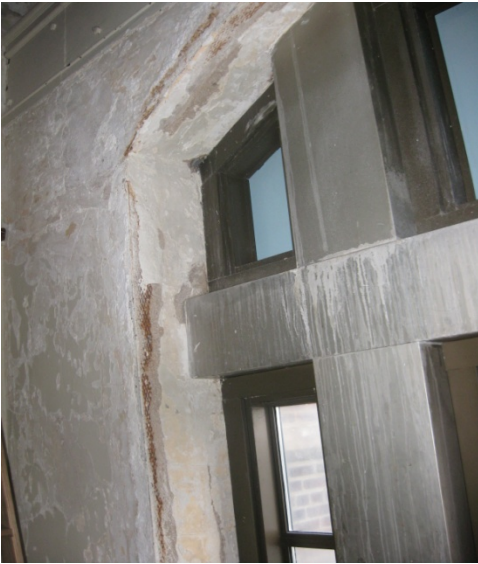
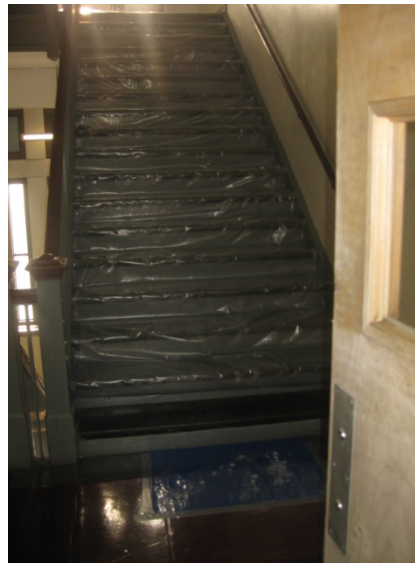
**Bayard Taylor Elementary School** – Before - Dampness in stairwell. After - Painting in progress.

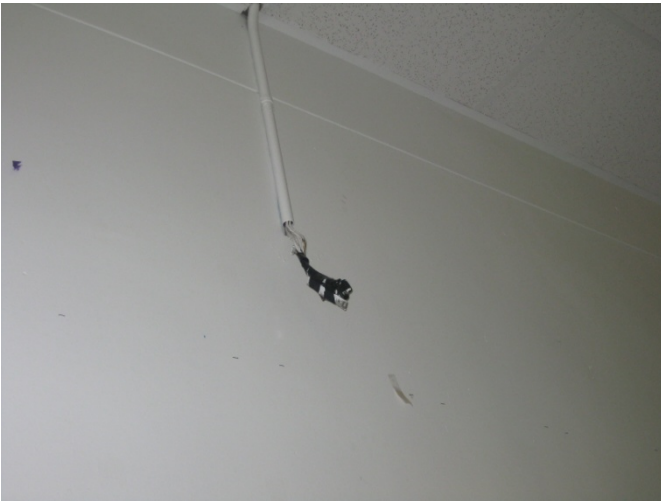
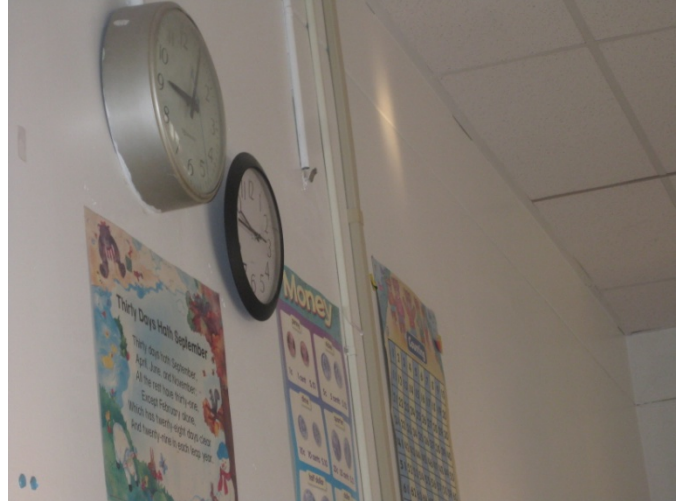
**Bayard Taylor Elementary School** – Before - Wires were improperly terminated. After - Wires are capped.

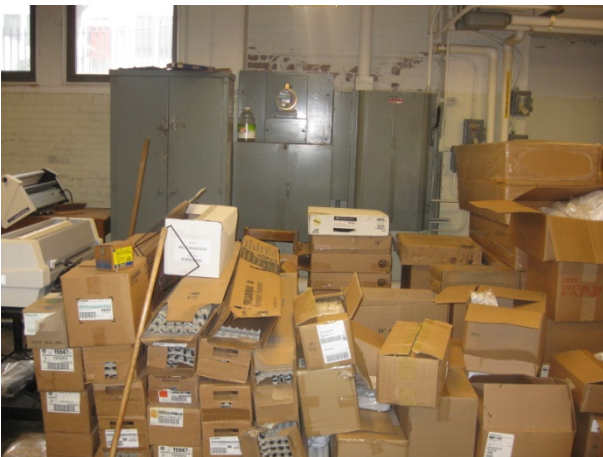
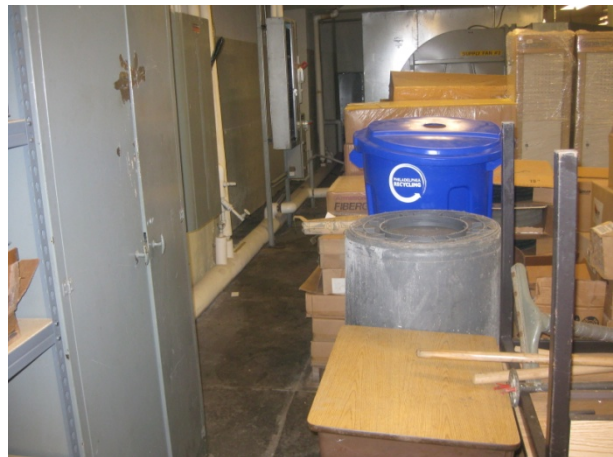
**Andrew Jackson Elementary School** – Before - Boxes in the electrical panel area. After - Boxes moved away from electrical panel and access provided.

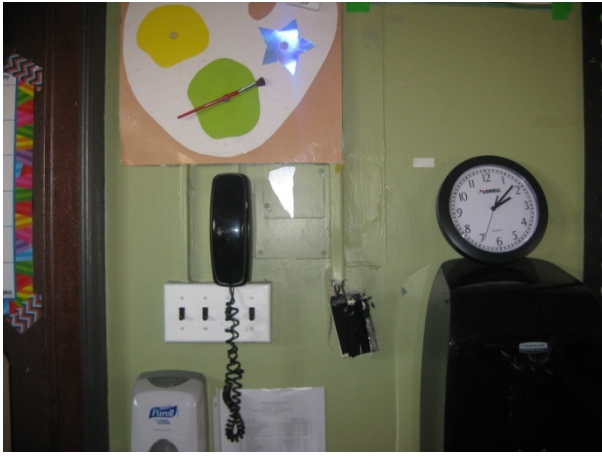
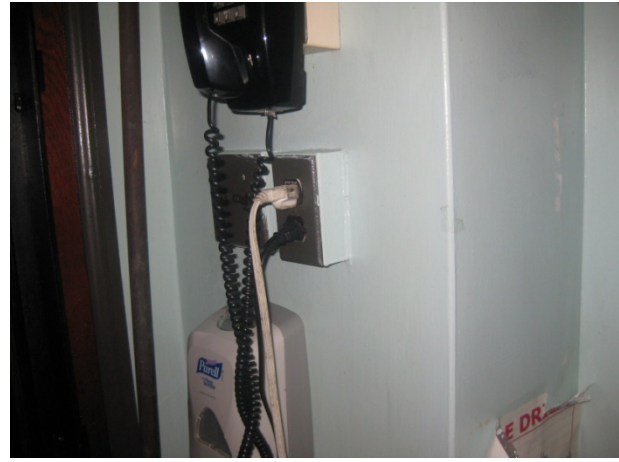
**Andrew Jackson Elementary School** – Before - Damaged outlet with exposed wires. After - Repaired outlet and wires.

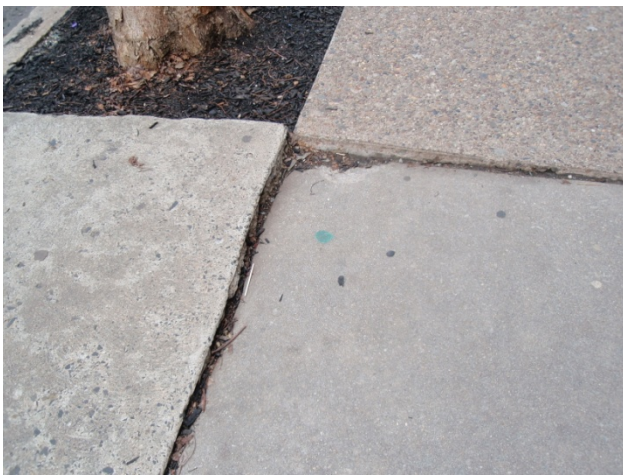
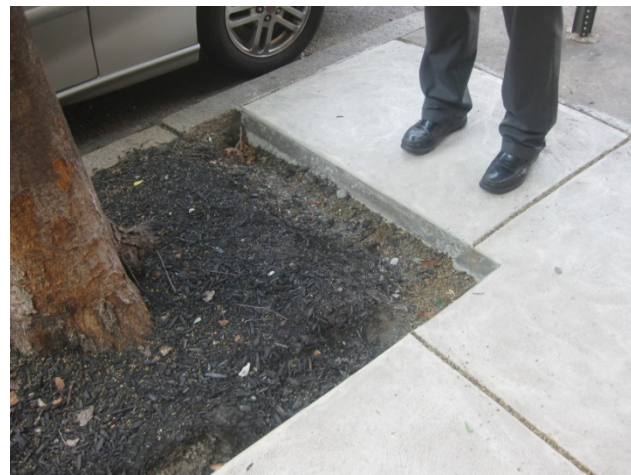
**Andrew Jackson Elementary School** –Before - Tripping hazard near tree pit. After - New sidewalk around tree pit.

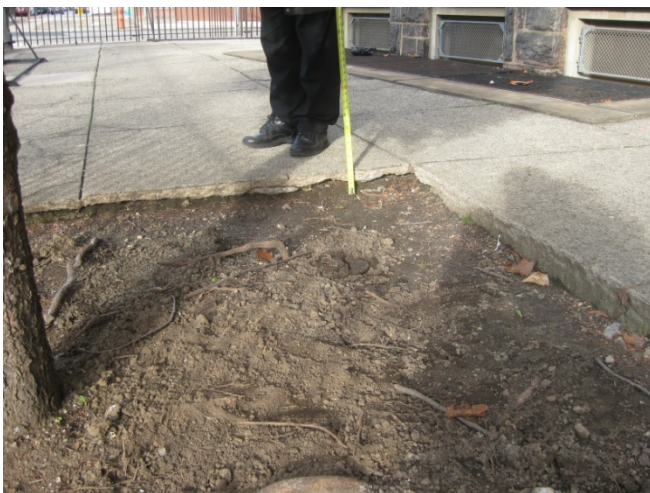
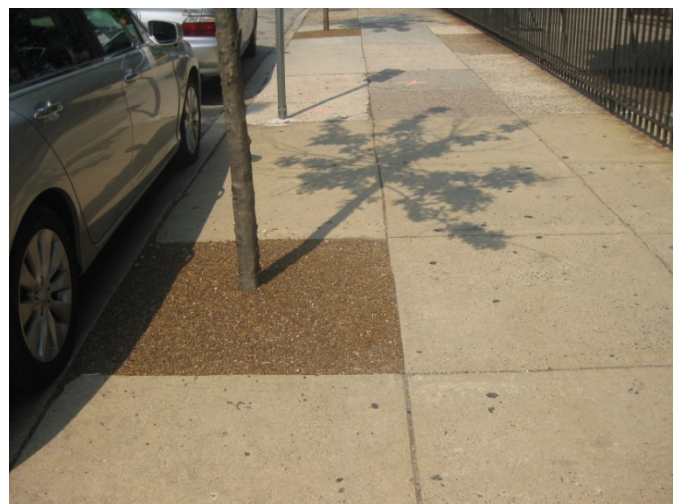
**General Kearny Elementary School** - Before - Tripping hazard at tree pit. After - A new tree pit.

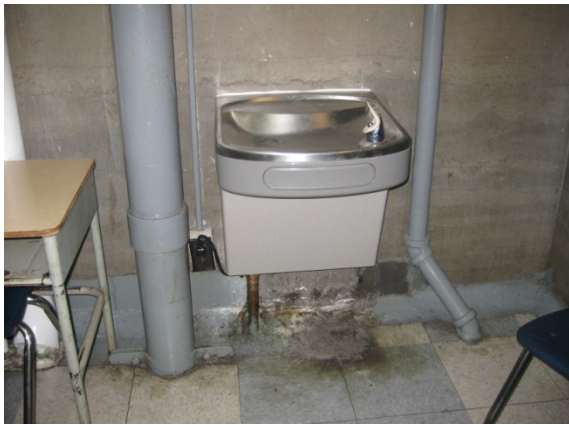
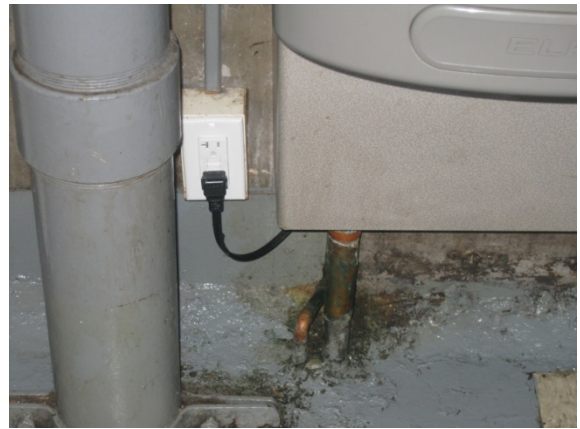
**General Kearny Elementary School** - Before - Water fountain without a GFCI outlet. After - GFCI outlet installed.

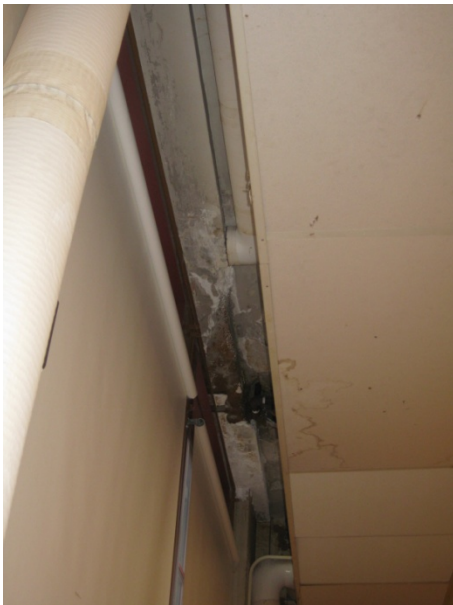
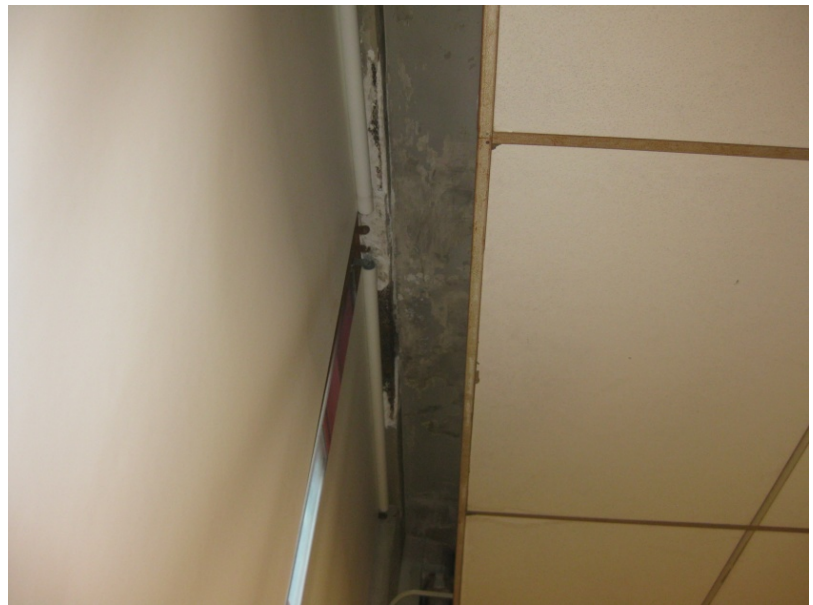
**Central High School** – Before - Leak from the ceiling. After - Leak fixed and tiles replaced.

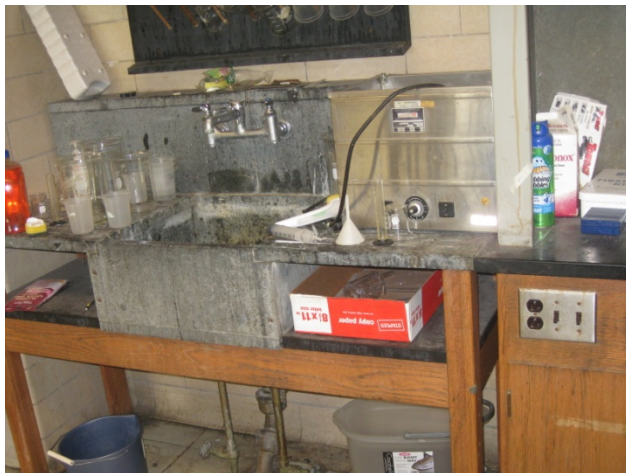
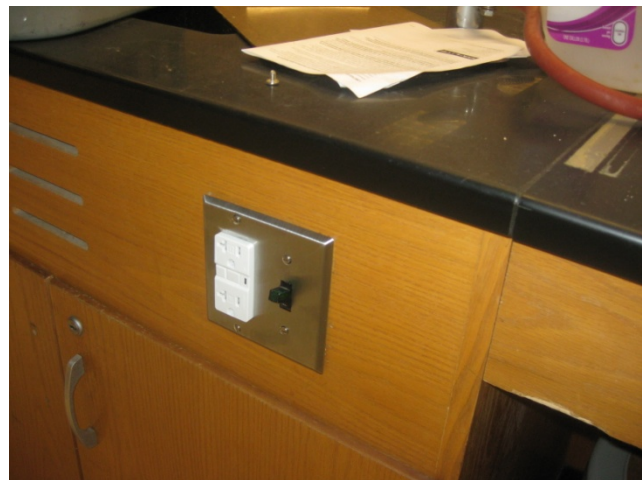
**Central High School** – Before - Outlet near a water source without a GFCI outlet. After - GFCI outlet installed.

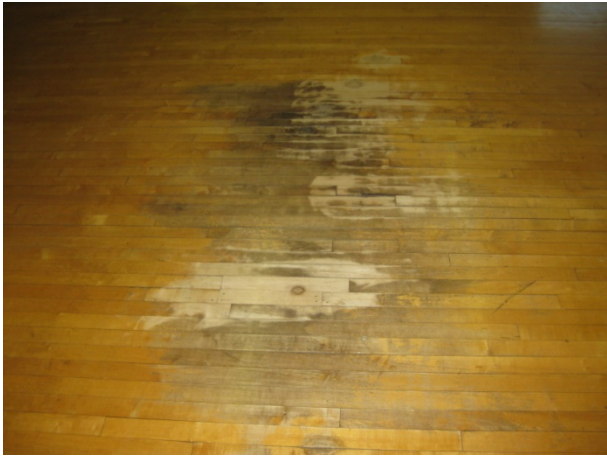
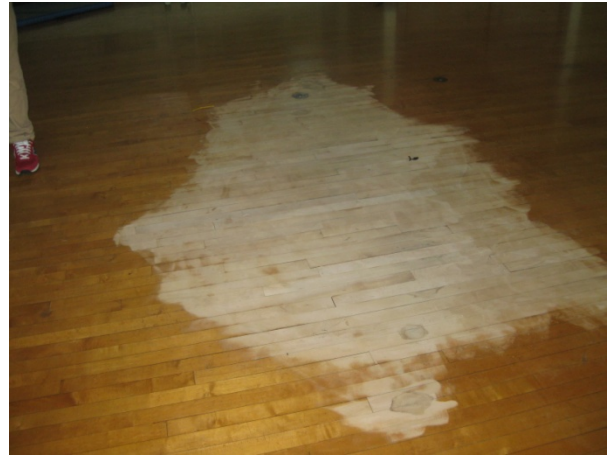
**George Washington High School** – Before - Buckled floor. After - Floor repaired.

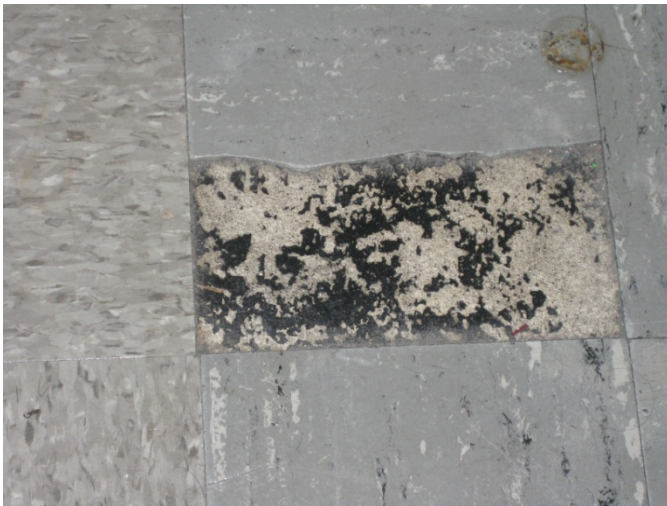
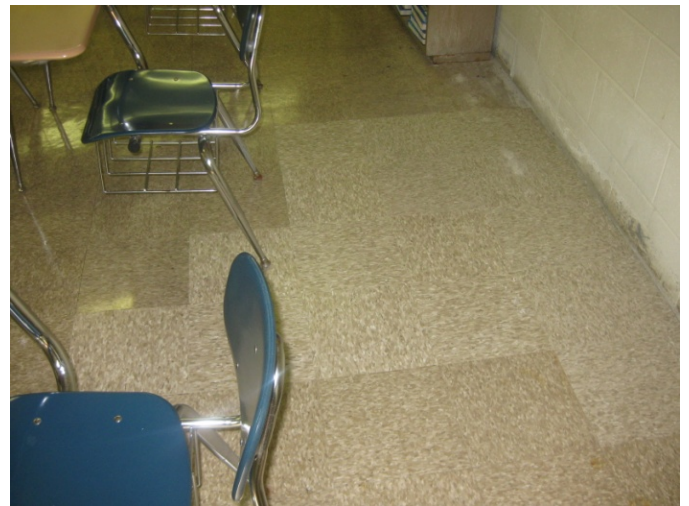
**George Washington High School** – Before - Damaged tile floor. After - Floor repaired.

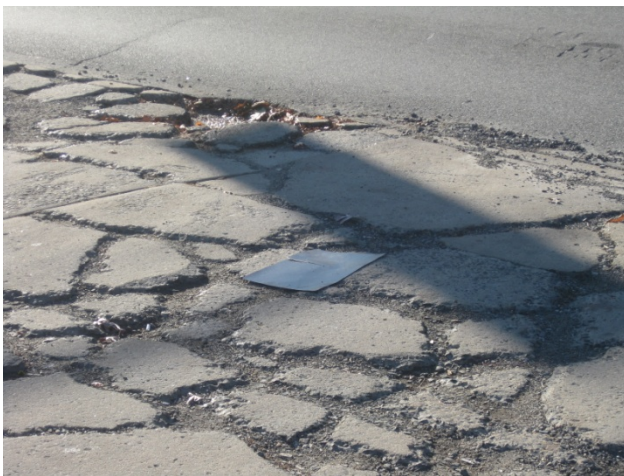
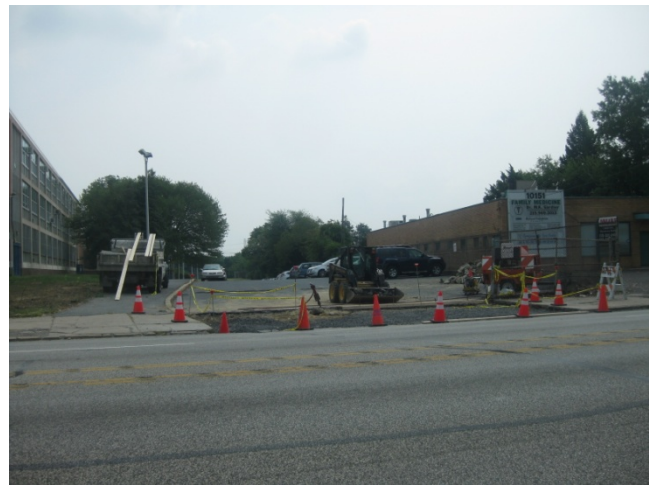
**George Washington High School** – Before - Exterior tripping hazard. After - Repair in progress.
