**PHILADELPHIA SCHOOL DISTRICT
FOLLOW-UP REVIEW OF CONDITIONS AT
SCHOOL BUILDINGS
JUNE 2015**

Philadelphia School District Follow-up Review of Conditions of School Buildings 2015

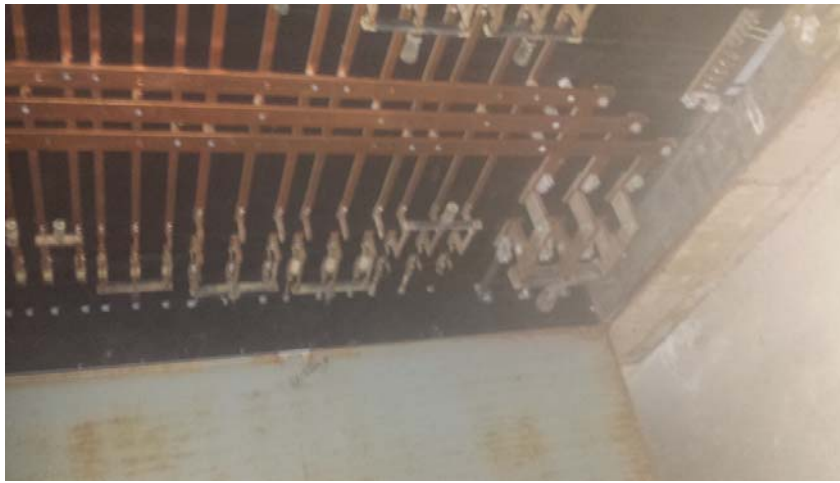
Large Electrical Closet Left Open George Washington High School had a large electrical closet for the auditorium left unlocked. This was a serious safety issue as the bus bars are rated at 600 volts. We had them lock this closet on the day we conducted our review. There was a smaller electrical closet open at Bayard Taylor Annex as well as at Dimner Beeber Middle School.

Open Electrical Closet: George Washington

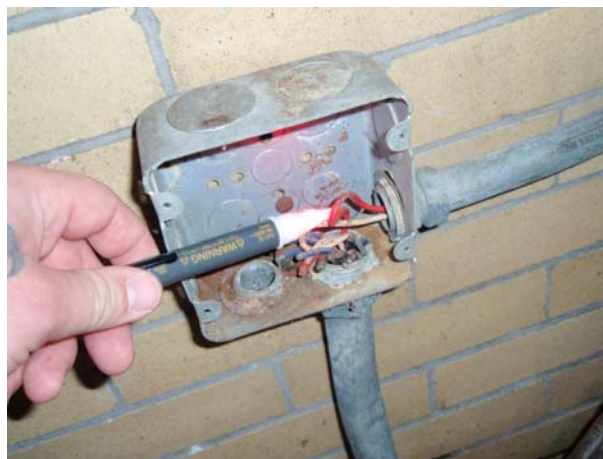
Exposed Wires. 70 percent of the sites had exposed wires that should be covered for safety. At several schools the wires were tested and it was confirmed that they were live.

Exposed Wires: Dimner Beeber - Classroom

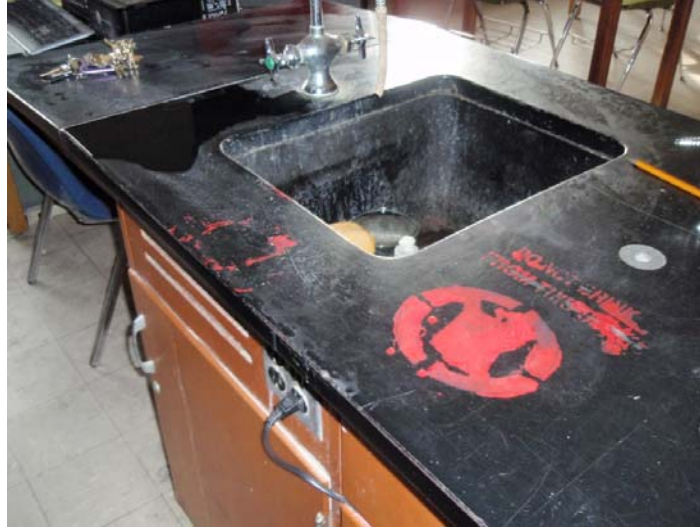
Missing GFCI outlets near water sources. The International Building Code requires Ground Fault Circuit Interrupters (GFCI) outlets within six feet of a water source to prevent electrical shocks. At 70 percent of the schools inspected we found at least one of the outlets near sinks and drinking fountains did not have these. GFCI outlets are relatively inexpensive and easy to install and could likely be done by the maintenance staff on site.

Outlet should have GFCI: Frankford High

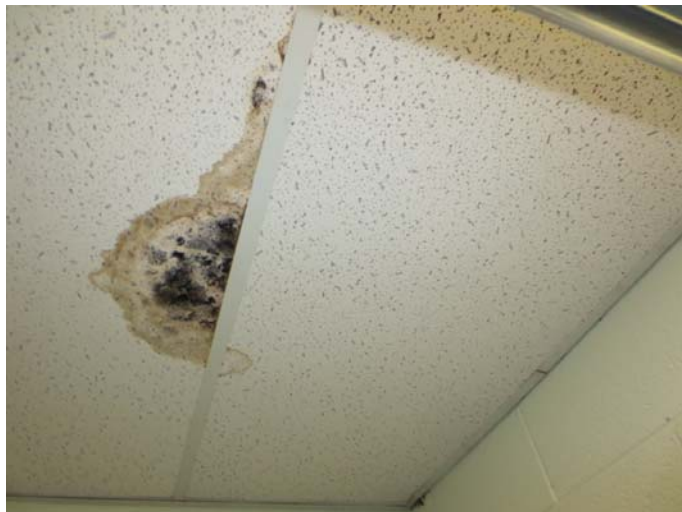
Every school we visited other than the newly constructed Fels School had evidence of water damage. The leaks causing these issues can be relatively inexpensive to fix compared to the amount of damage that can be caused by the leaks. The water damage can be seen from discolored ceiling tiles and stains on the walls and floors and bubbling paint due to moisture. In several of the schools leaking water can lead to slipping hazards as the water is falling onto the floor. Several of the schools had what appeared to be mold on ceiling tiles due to water leaks (as pictured below).

Water Damage: Cooke-Wissahickon

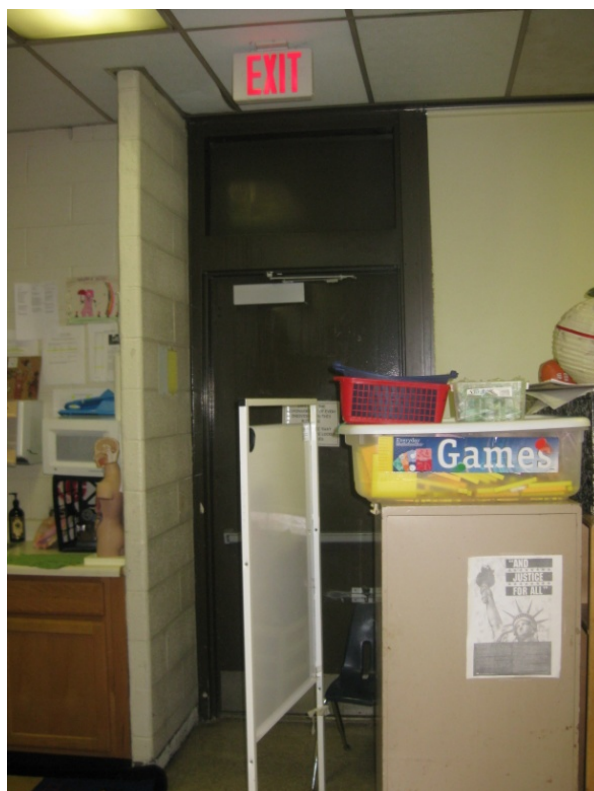
Egress Issues: 35 percent of the schools we visited had hallways that were blocked with objects, or large items in front of fire exit doors which led to egress issues that are in violation of the fire code.

Blocked Fire Exit: McKinley - Classroom

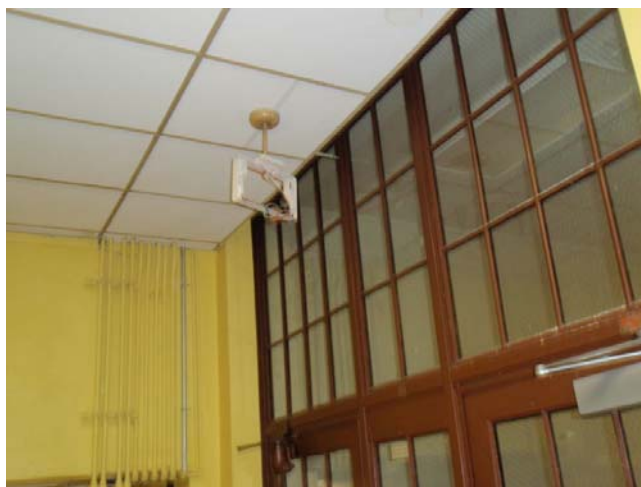
Fire Signs: 20 percent of the schools had damaged or missing fire signs. This is a fire code violation.

Damaged Fire Exit Sign: Martha Washington

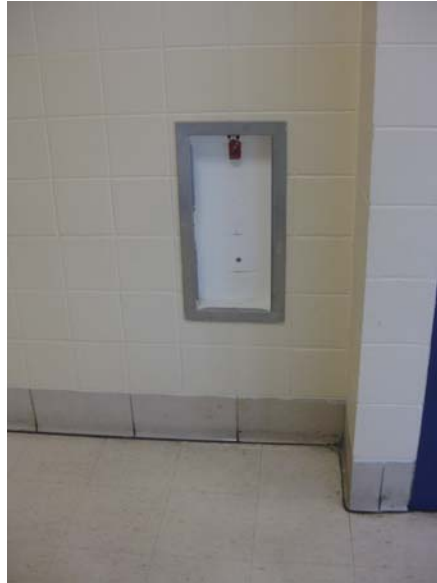
Expired fire extinguishers 65 percent of the schools had fire extinguishers that were expired, missing, or not adequately charged. We found several extinguisher holders which were empty, resulting in extinguishers not placed in the proper locations, such as in a kitchen where it may be used in the case of a fire.

Missing Fire Extinguisher: Julia DeBurgos - Hallway

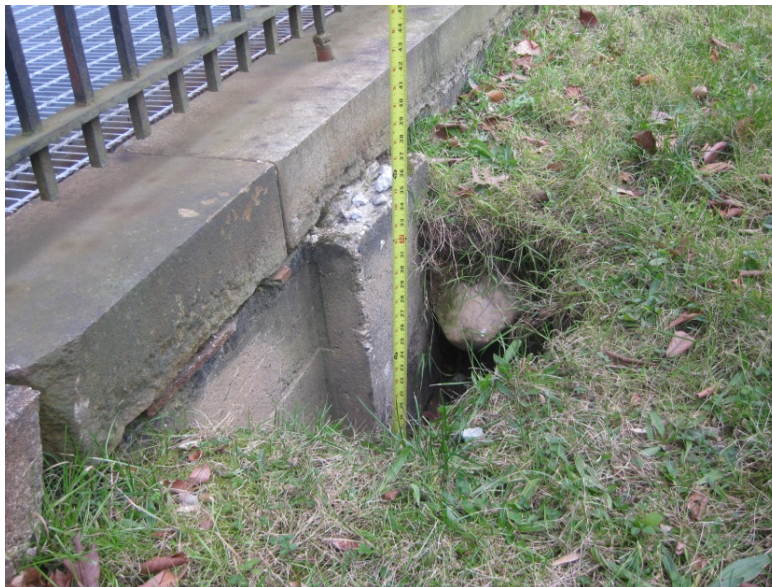
Tripping can lead to major injuries and potential liability for the schools. Gaps in the pavement and holes in the ground are a major issue at the sites visited. These areas should be analyzed and addressed to reduce liability and to improve the safety and appearance of the schools.

Tripping Hazard: Central

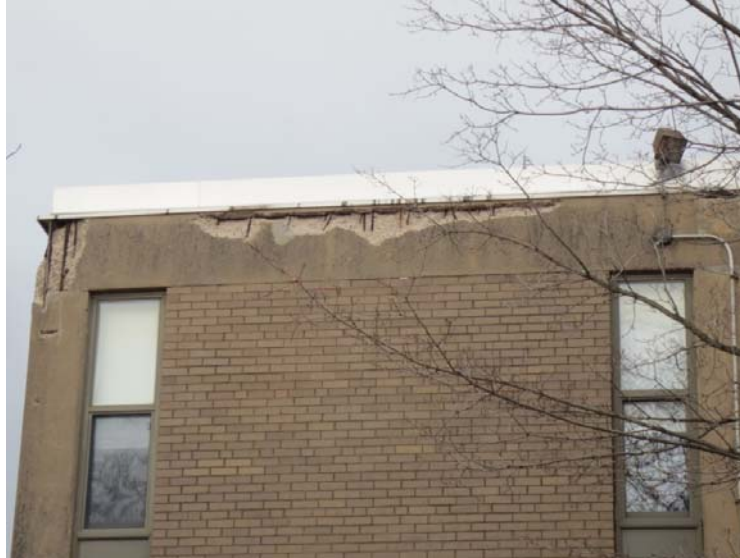
Many of the sites had damaged masonry varying from damaged steps to crumbling masonry fences to exposed rebar on the sides of the schools.

Damaged Masonry: Cooke Wisahickon

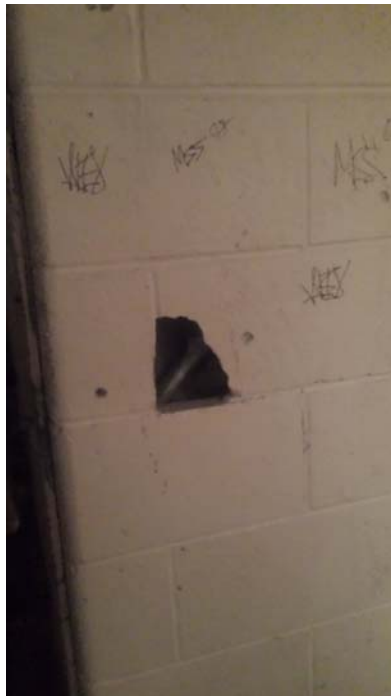
Some of the damage included peeling paint, holes in walls, damaged plaster, and damaged drywall.

Damaged Masonry Wall: George Washington –Auditorium Backstage

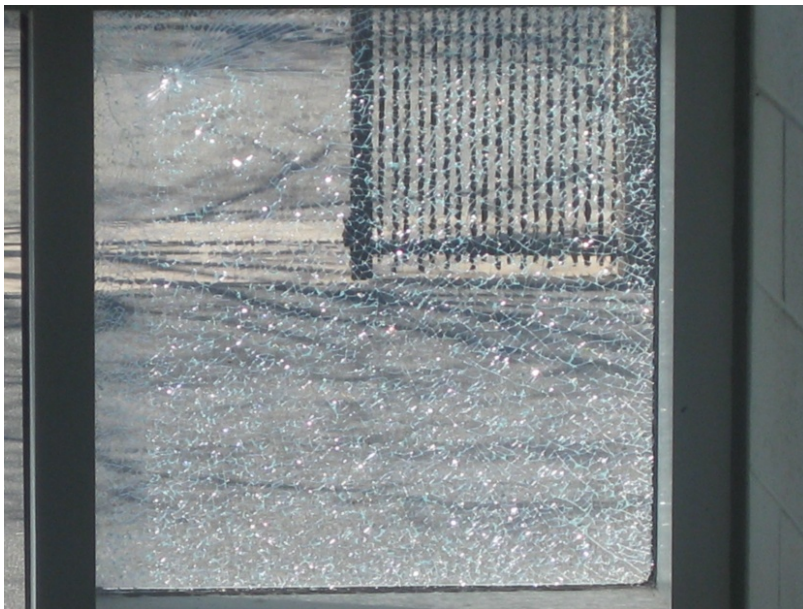
We found broken windows that were not properly addressed or maintained in an unsafe manner.

Cracked Glass: Lawton –Stairwell Window

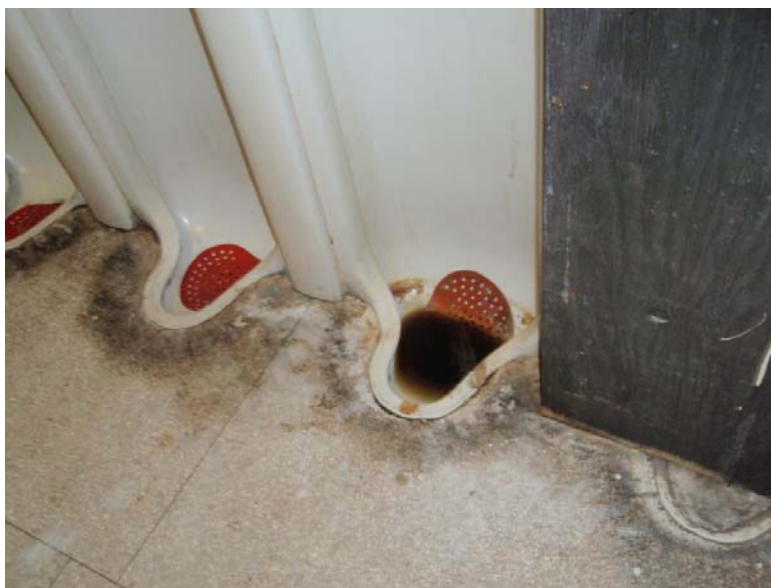
Unsanitary Conditions: 20 percent of the schools had toilets that appeared to have waste permanently in them.

Unsanitary Toilet: Dimner Beeber

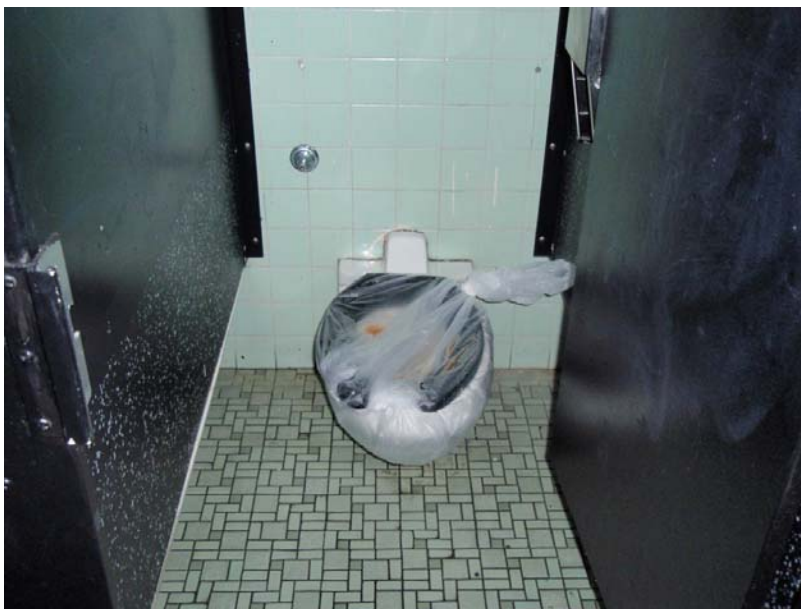
Out of order toilets: 50 percent of the schools had toilets that were out of order.

Out of order toilet: Frankford

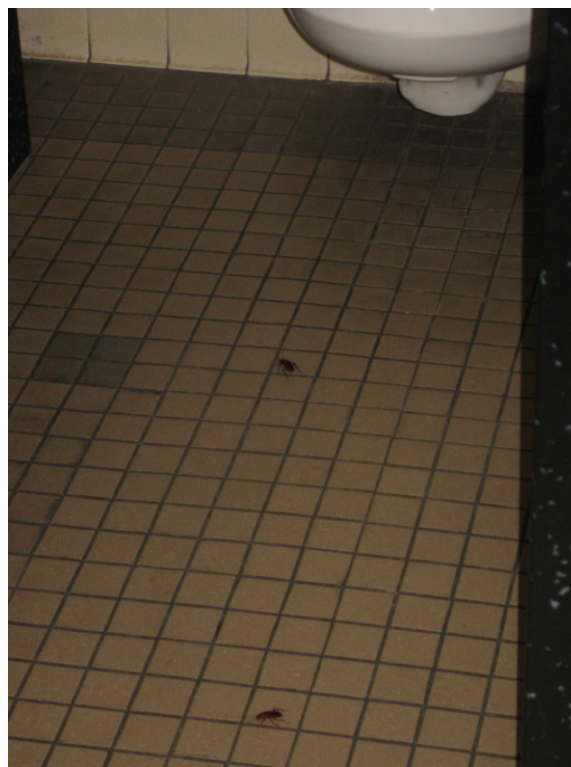
At Central High School we witnessed cockroaches in the restroom.

Cockroaches in the Restroom: Central

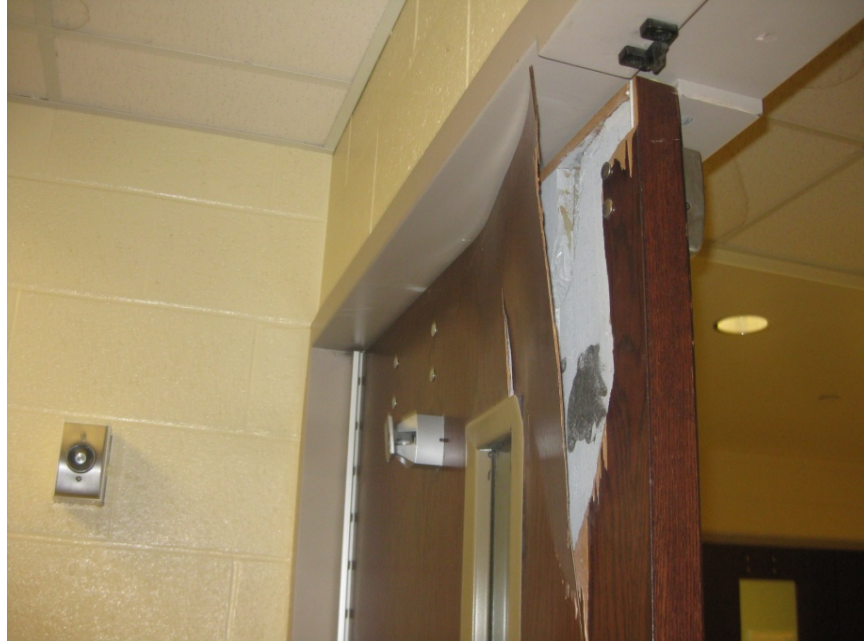
We found damaged doors that were splintered in an unsafe manner.

Damaged Doors: Fels

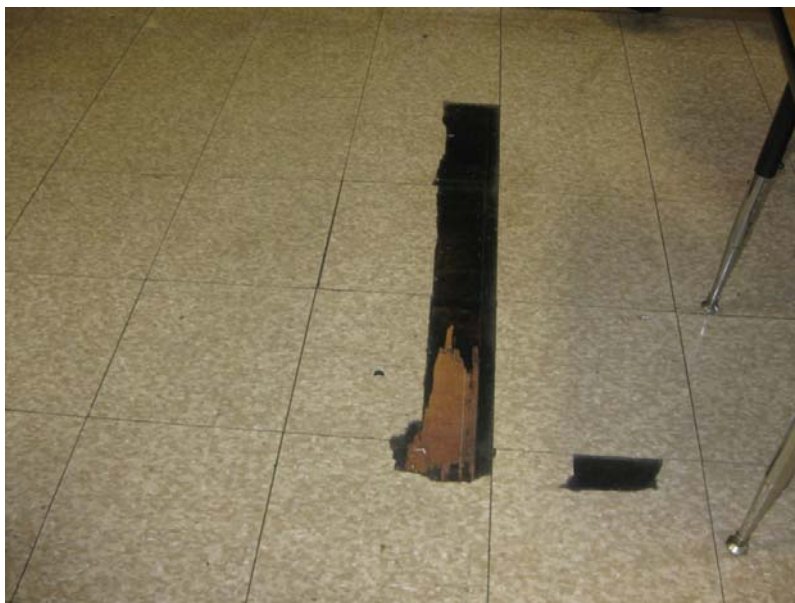
We found damaged flooring that could result in tripping and further deterioration of the floors.

Damaged Flooring: Bayard Taylor Annex – Classroom

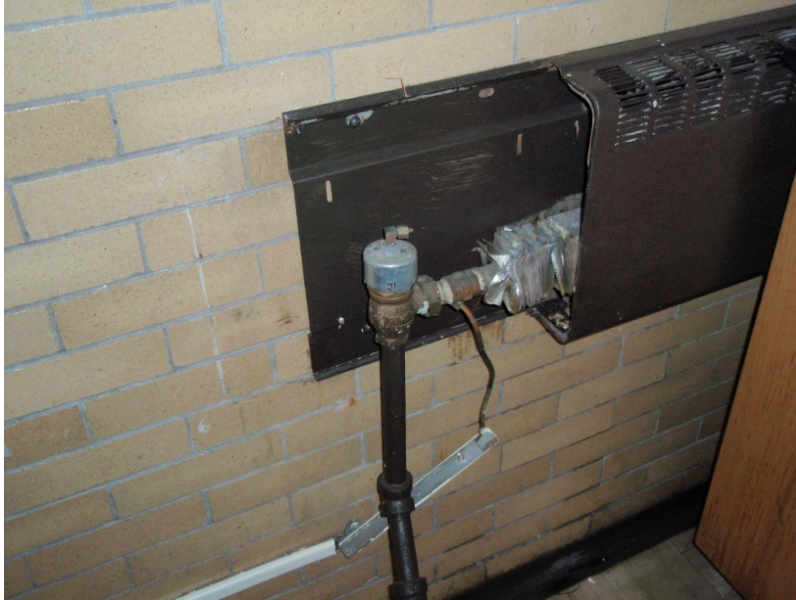
We found damaged heating systems with covers missing. In certain classrooms we also found heaters that either did not work properly or that did not work at all.

Damaged Heating System: Dimner Beeber

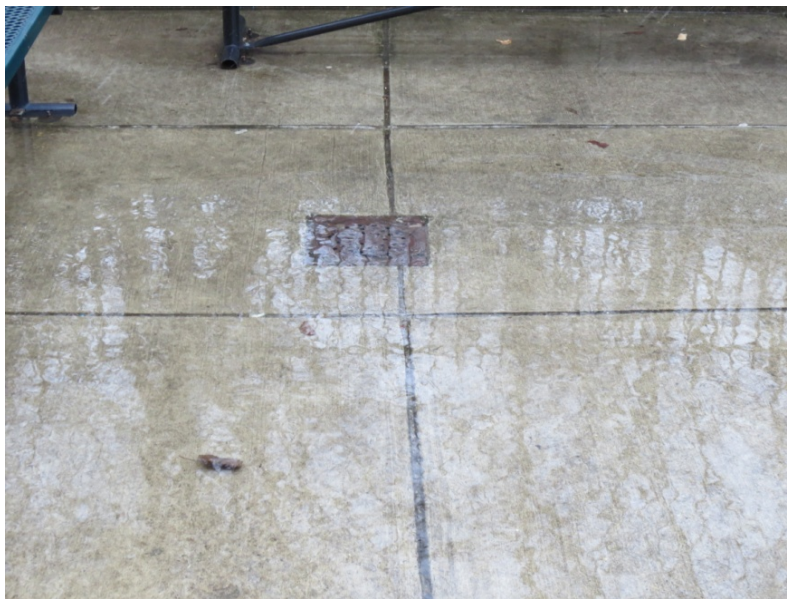
Outdoor storm drains were clogged at 25 percent of the sites, causing minor flooding issues as well as possible mosquito problems and the associated health issues.

Clogged Storm Drain: Shawmont

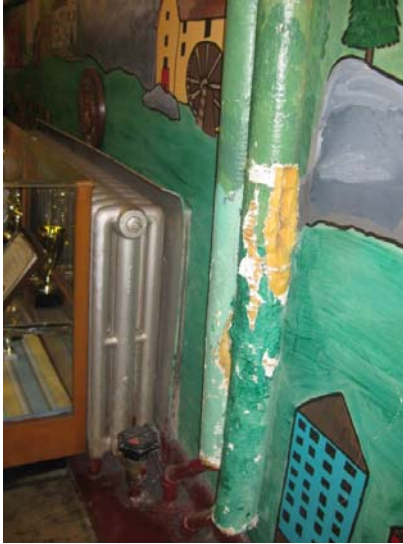
45 percent of the schools had damaged insulation on pipes. This insulation can be a health hazard when particles are released into the air.

Exposed Insulation: John Story Jenks - Hallway

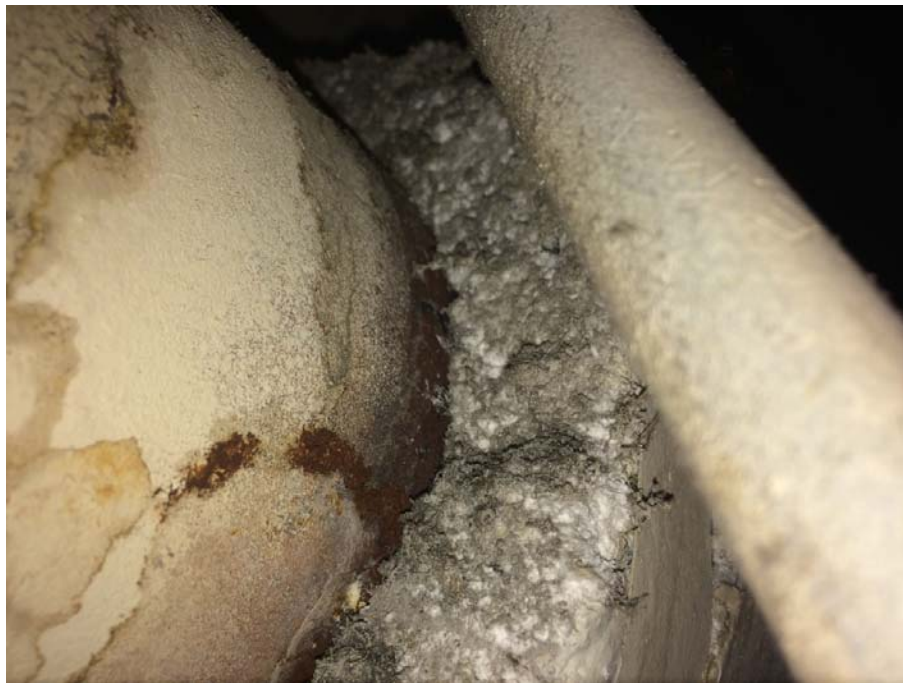
In the basement hallway near the lunchroom there is a long pipe which is wrapped in asbestos insulation that does not appear to be properly terminated in several places. Asbestos insulated pipes are in many schools throughout the country which is considered an acceptable practice as long as the pipe is properly encased. However, as shown below, the pipe at Francis Scott Key does not appear to be properly encased.

Asbestos insulation improperly terminated on a large pipe: Francis Scott Key - Hallway

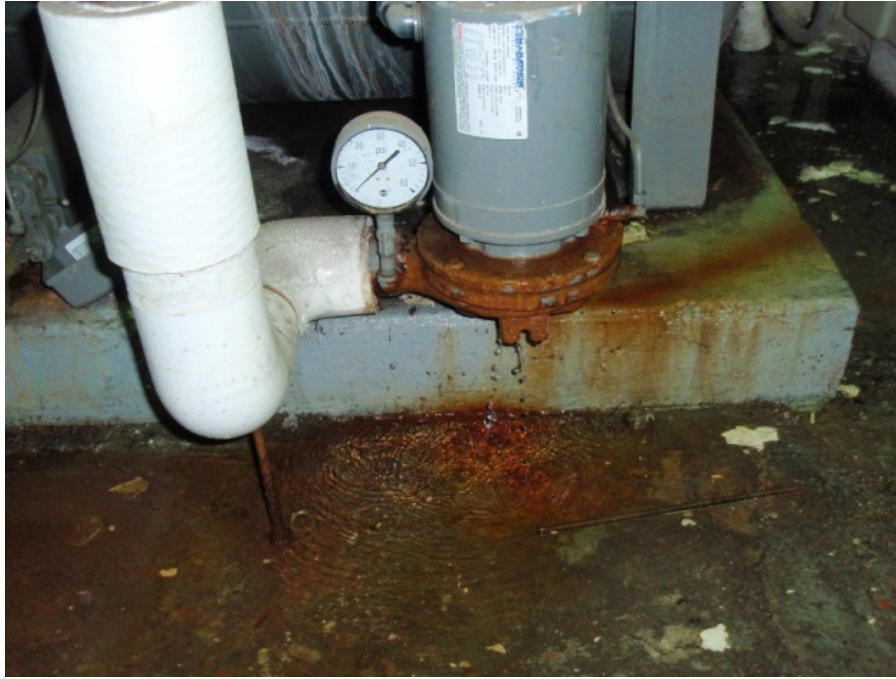
At least 30 percent of the mechanical rooms in the inspected schools had at least one piece of equipment leaking which often led to standing water.

Leaking in the Mechanical Room: Dimner Beeber

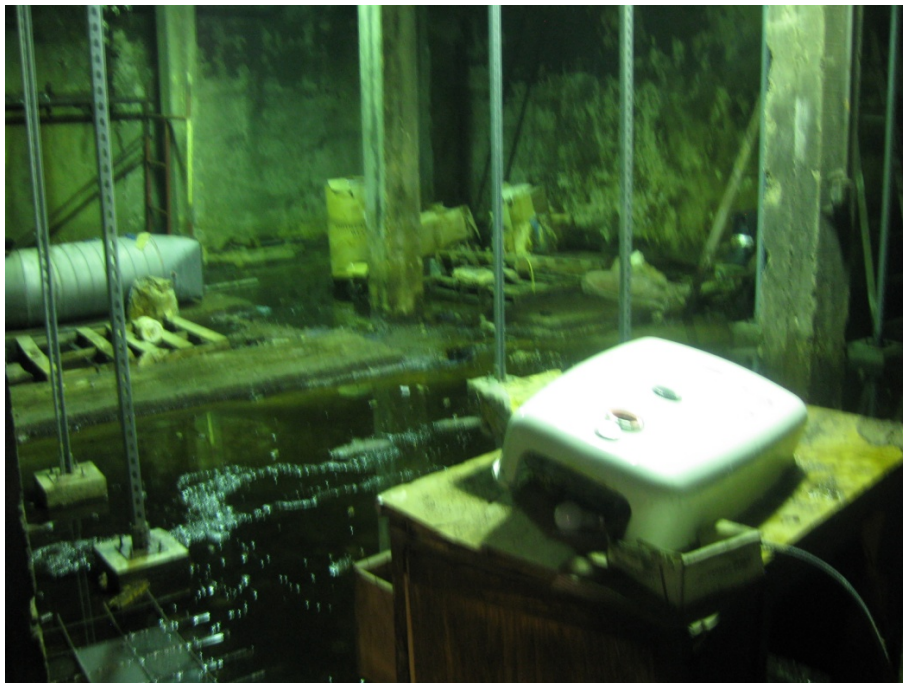
Structural Wall Leaking at Kearny The basement in Kearny leaks and is filled with standing water. This should be immediately investigated and repaired as required.

Leaking in the Mechanical Room: Kearny

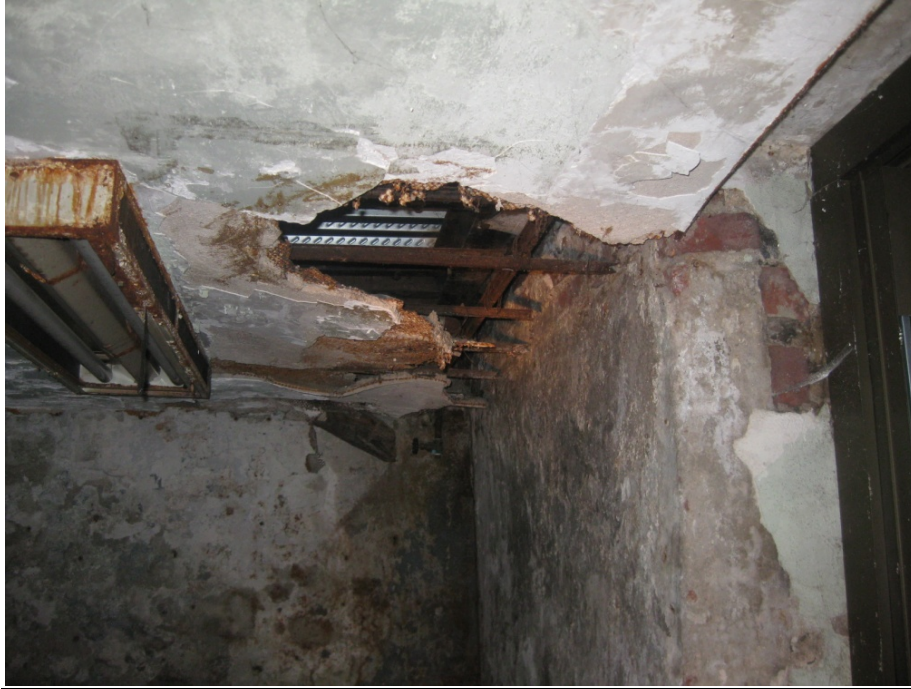
Structural Issues at Bayard Taylor Annex The ceiling at Bayard Taylor does not appear to be structurally sound in the basement of the annex building. This should be immediately investigated and repaired as required.

Structural Problems: Bayard Taylor Annex Basement

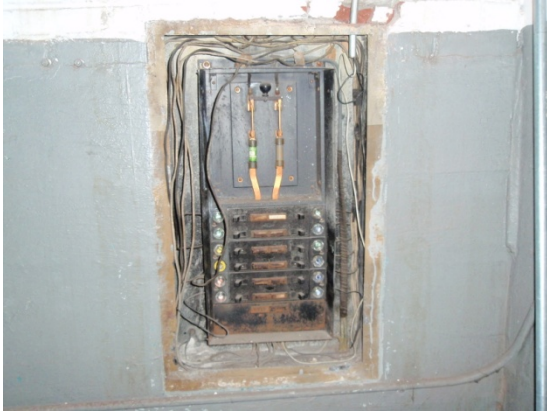
Figure 1 - Exposed Electrical Panel - Dimner Beeber

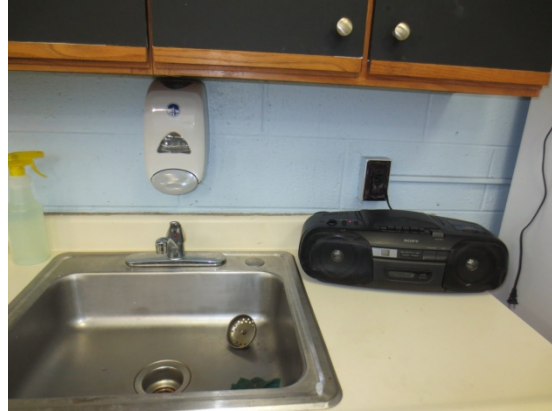
Figure 2 – Outlet next to a sink that should be a GFCI outlet – Cooke Wisahickon

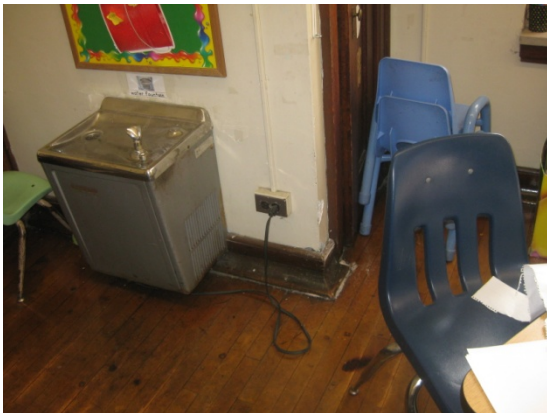
Figure 3 – Outlet next to a water fountain should be a GFCI outlet - Crossan

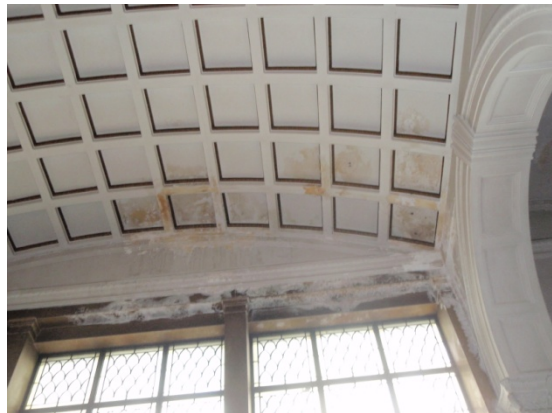
Figure 4 – Water Damage – Dimner Beeber

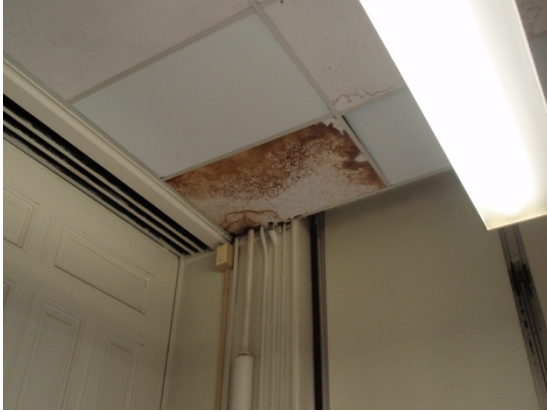
Figure 5 – Water Damage – Francis Scott Key

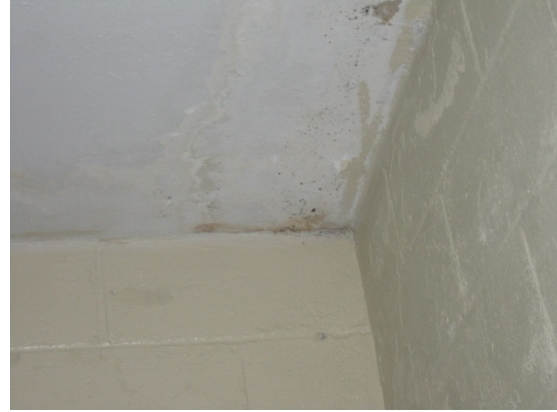
Figure 6 – Water Damage with Possible Mold – George Washington

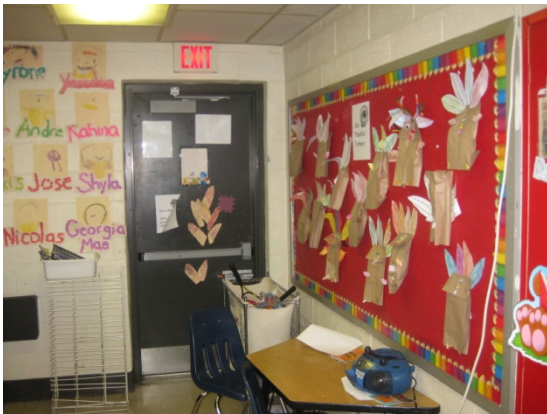
Figure 7 – Blocked Fire Exit – Bayard Taylor

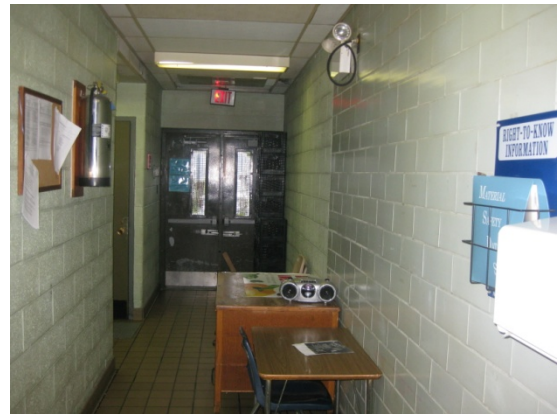
Figure 8 – Blocked Egress to Fire Exit – Bayard Taylor

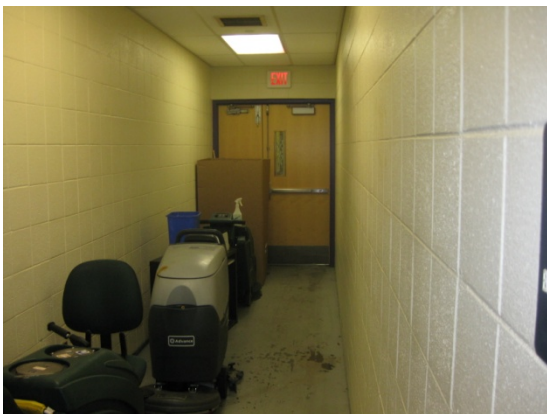
Figure 9 – Blocked Egress to Fire Exit – Julia Deburgos

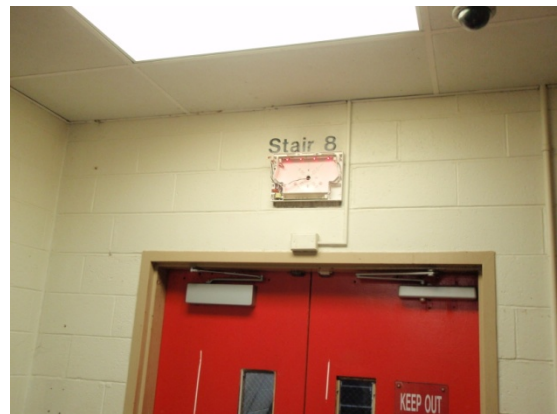
Figure 10 – Damaged Fire Exit Sign - Frankford

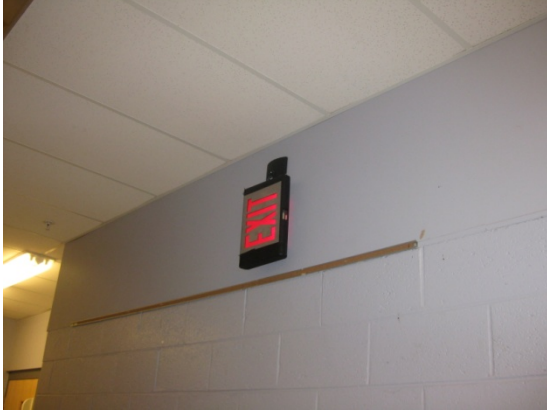
Figure 11 – Damaged Fire Exit Sign – Juniata Park

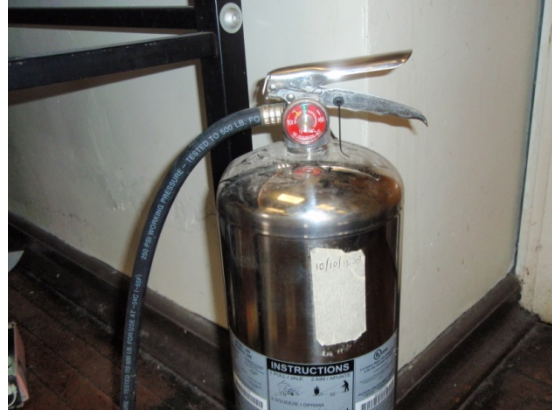
Figure 12 –Expired and Empty Fire Extinguisher – Dimner Beeber

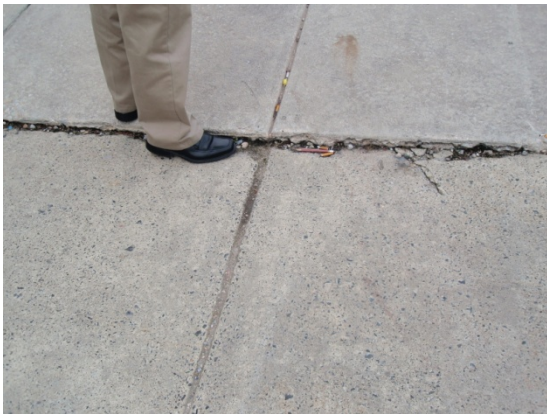
Figure 13 – Tripping Hazard – Dimner Beeber

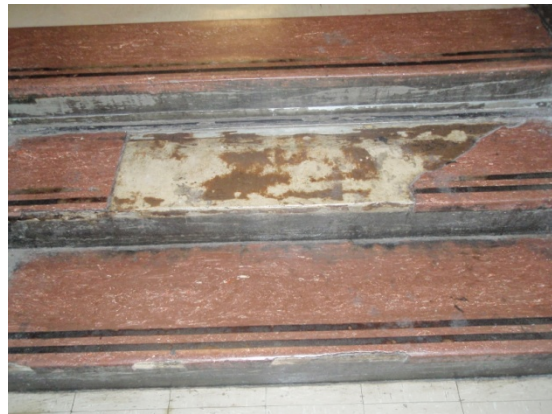
Figure 14 – Tripping Hazard, Damaged Step - Frankford

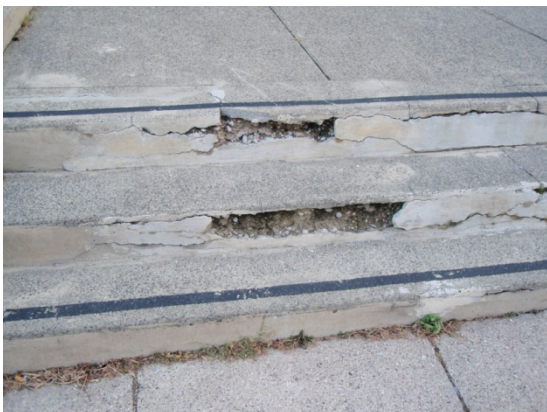
Figure 15 – Damaged Masonry Steps - Overbrook Education Center

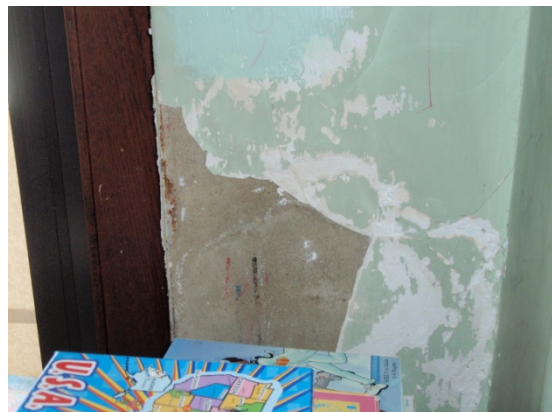
Figure 16 – Damaged Wall - Dimner Beeber

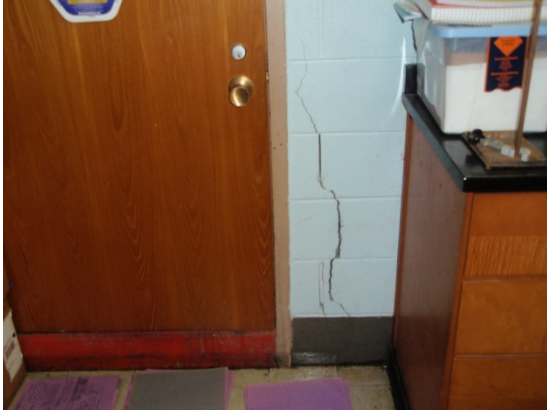
Figure 17 – Damaged Masonry Wall - Frankford

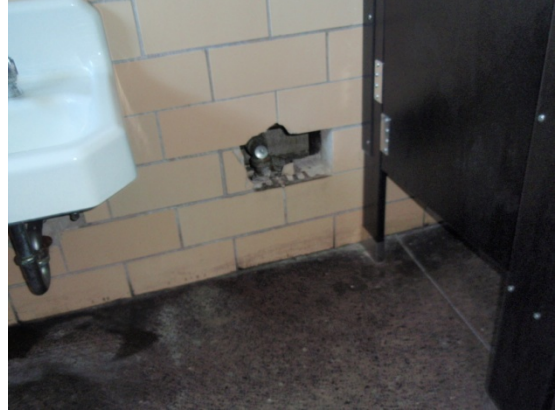
Figure 18 – Hole in Restroom Wall - Martha Washington

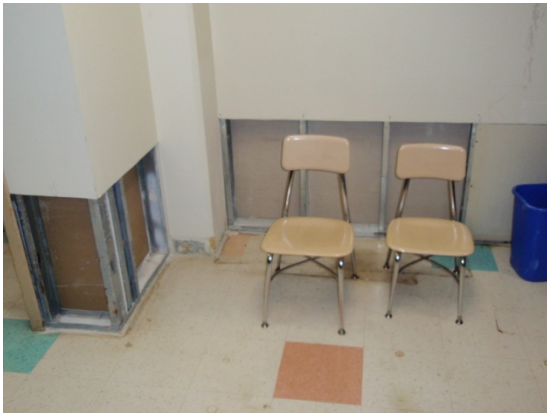
Figure 19 – Damaged Drywall – Overbrook Education Center

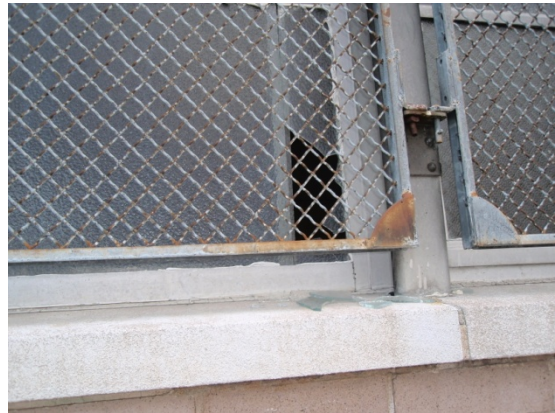
Figure 20 – Broken Window – Martha Washington

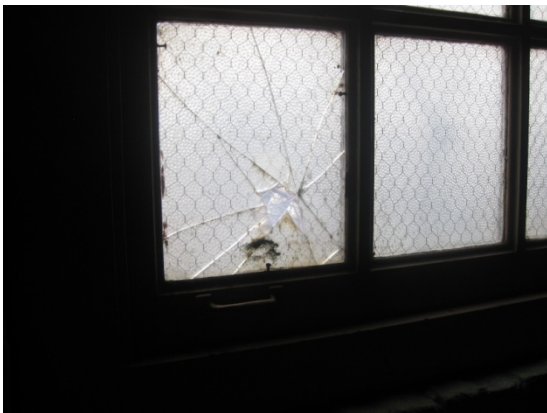
Figure 21 – Broken Window – Bayard Taylor

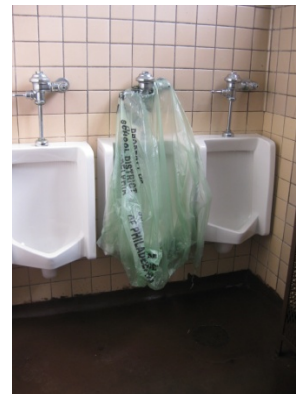
Figure 22 – Out of Order Urinal - Jackson

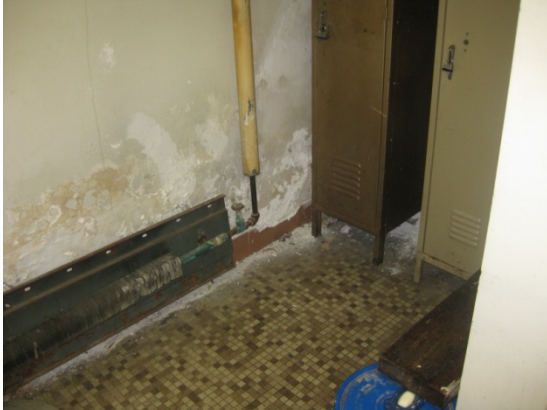
Figure 23 – Damaged Heating Unit – Bayard Taylor

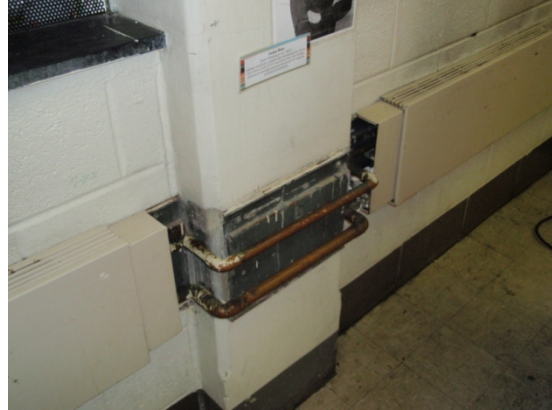
Figure 24 - Missing Heater Cover - Frankford

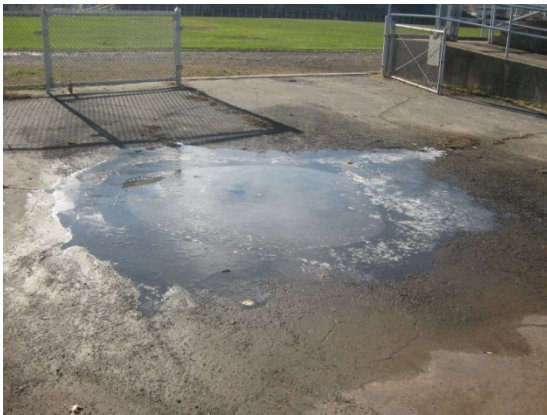
Figure 25 - Drainage Issues – George Washington

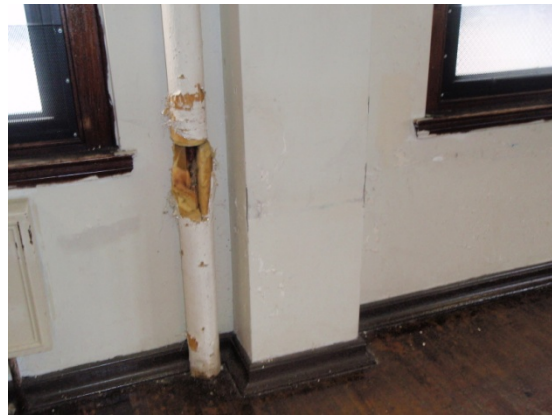
Figure 26 – Exposed Insulation – Dimner Beeber

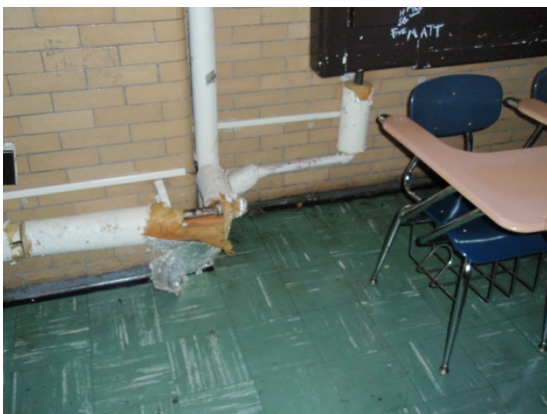
Figure 27 – Exposed Insulation – Dimner Beeber

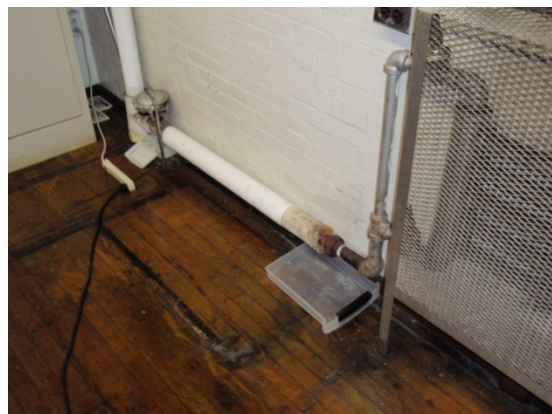
Figure 28 – Exposed Insulation and Leaking Heater – Francis Scott Key

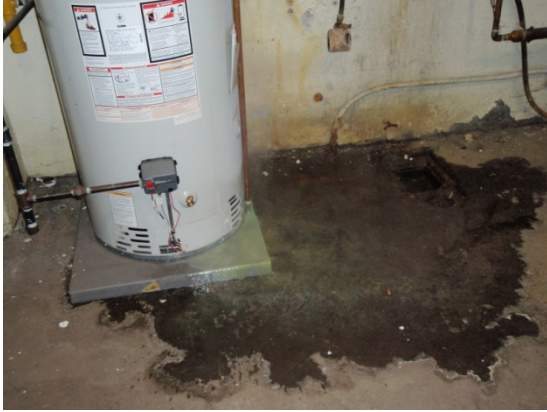
Figure 29 – Leaking Water Heater – Dimner Beeber

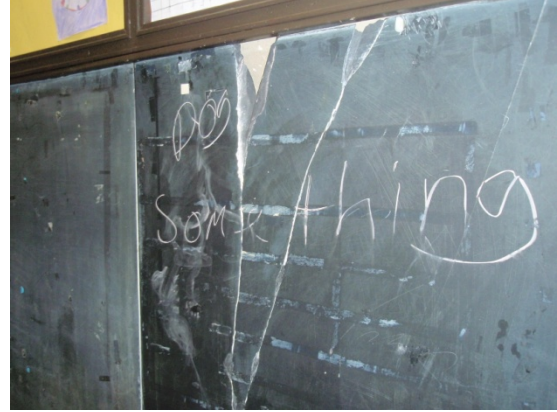
Figure 30 – Cracked Chalk Board – Dimner Beeber

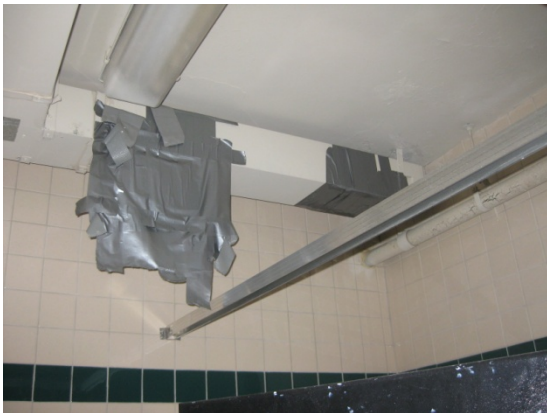
Figure 31 – Damaged Air Duct – John Story Jenks
