OFFICE OF THE CONTROLLER

**VIDEO SURVEILLANCE SERVICE PROJECT**

**2013 FOLLOW-UP**

**MAY 2013**

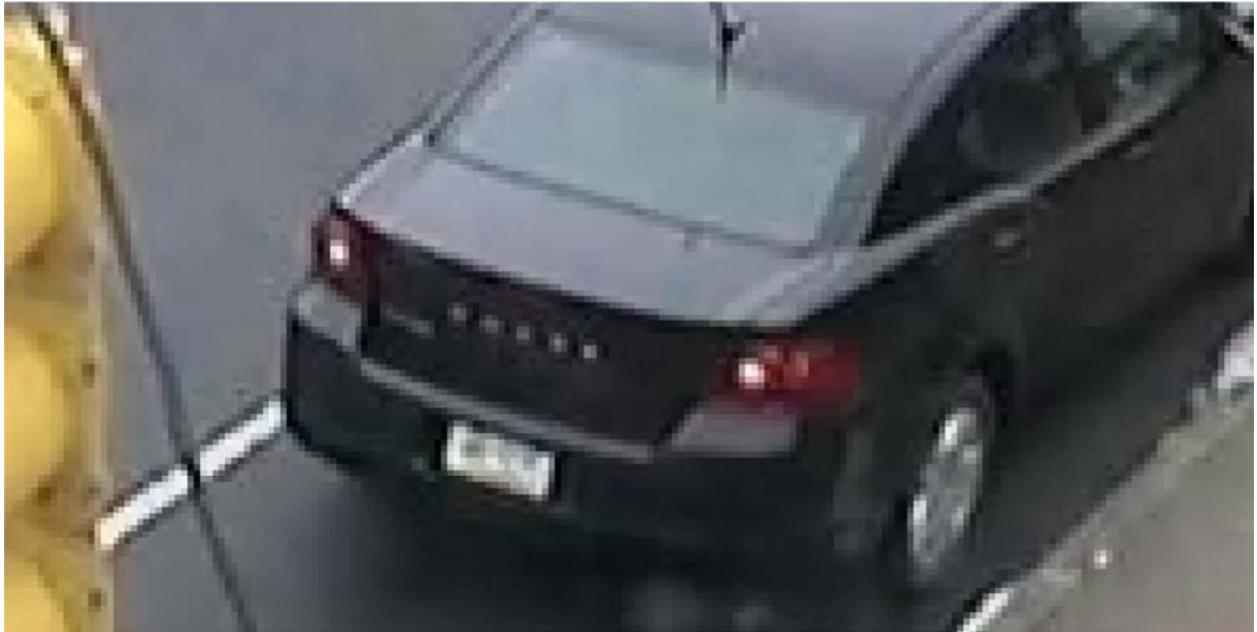
*Illustration 1 – Post-incident*

The most significant shortcoming with viewing historical video is that, should there be a need to zoom in on an image – such as a license plate - the zoomed image is heavily pixelated and unreadable. See *Illustrations 1* and *2* below for examples of the quality of a zoomed image taken from video.

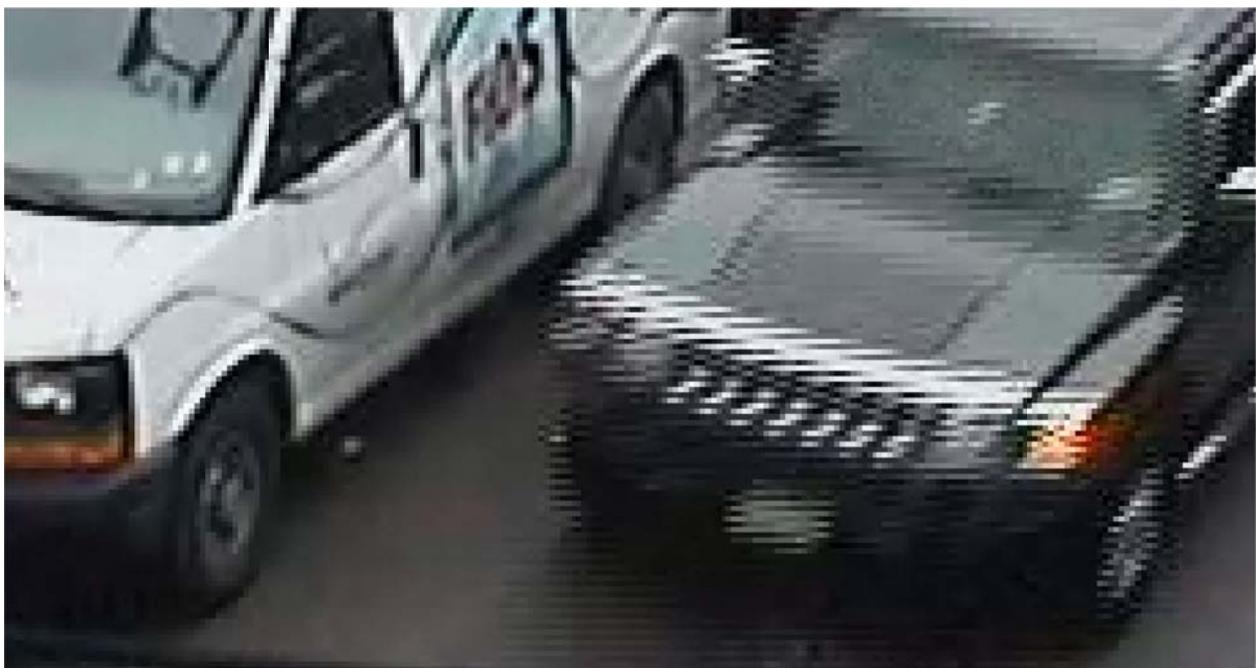
*Illustration 2 – Post-incident*

Accordingly, once a camera view is recorded in real time, the PPD does not have the ability to view a different image or improve upon the recorded image. Although video can be sent out to third parties for post-processing so that attempts to enhance images that may be needed as evidence in the most critical cases can be made, doing so is atypical primarily due to the time and cost involved.

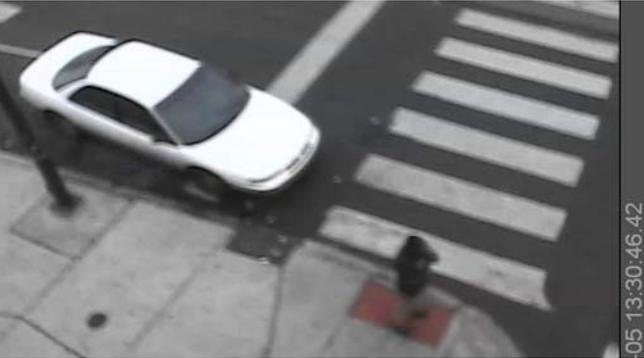
25-014	BLR/BNW: EA’s 2/5/2013 observation found very blurry images (all views); color was off, black & white with only red, no other colors. Condensation, fogginess or some other issue was noted. EA’s 2/13/2013 observation noted that the images were still blurry but marginally improved.
16-002	PTZ/BNW: EA’s 2/5/2013 observation found that the camera may have been tagged with the wrong street address; Intermittent panning with views at strange angles. Color appeared to be off, black & white with spotty reds, oranges. EA’s 2/13/2013 observation noted the same conditions.

Sample No.	Location/ (OIT ID)	EisnerAmper's Observation 2/5/2013	Conditions/Comments	OIT Status (2/12/2013)	Image
1	Broad & Erie (25-014)	Problems with Camera	<ul style="list-style-type: none"> <li>• very blurry images with zoom</li> <li>• could not see individual under camera with zoom</li> <li>• no identifiable features without zoom</li> <li>• black and white only, some red</li> <li>• condensation, fogginess</li> </ul>	Working/ Visual Inspection

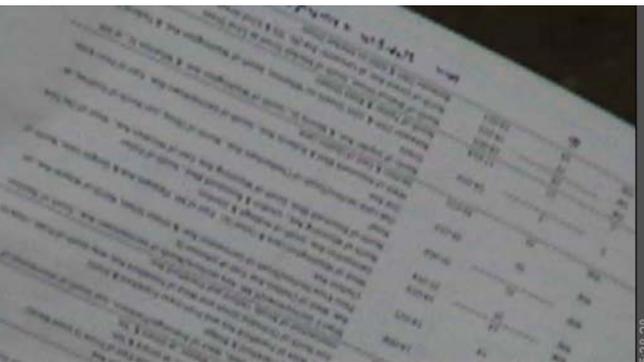
2	5238 Lansdowne Ave (19-025)	Problems with Camera	<ul style="list-style-type: none"> <li>• image of print at close zoom under camera is blurred</li> <li>• cannot read license plates or see facial features clearly without zoom</li> <li>• blurry at very close zoom in</li> <li>• auto-tour not functional</li> </ul>	Working/ Visual Inspection

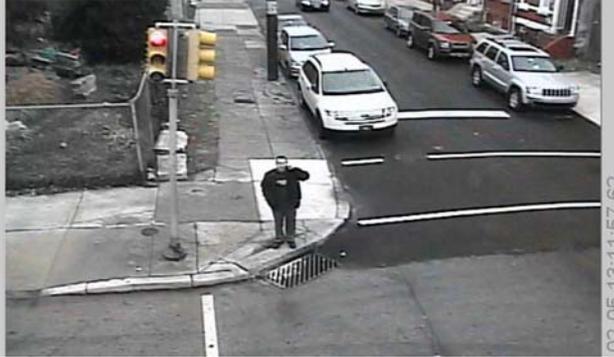
Sample No.	Location/ (OIT ID)	EisnerAmper's Observation 2/5/2013	Conditions/Comments	OIT Status (2/12/2013)	Image
3	15 <sup>th</sup> & Thompson St. (23-035)	Problems with Camera	<ul style="list-style-type: none"> <li>black and white picture with spotty colors (some red and blue)</li> <li>zoom at 20-25' renders grainy image with no identifiable features discernable</li> <li>close zoom blurry</li> <li>at 70' zoom, some images are clear, others are not</li> </ul>	Working/ Visual Inspection

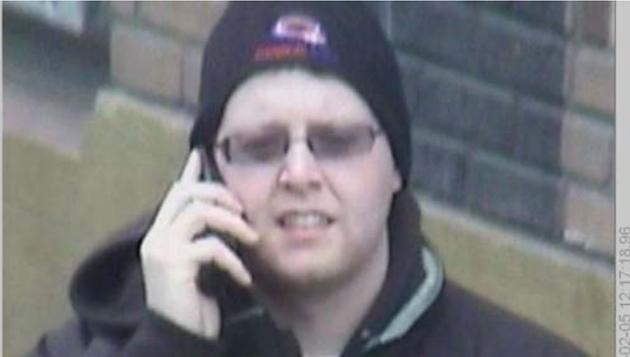
4	Hicks & Wharton St. (17-014)	Functioning Camera	<ul style="list-style-type: none"> <li>without zoom, do not know if subject is B/W, M/F</li> <li>zoom at 100' becomes clear, can see face</li> </ul>	Working/ Visual Inspection

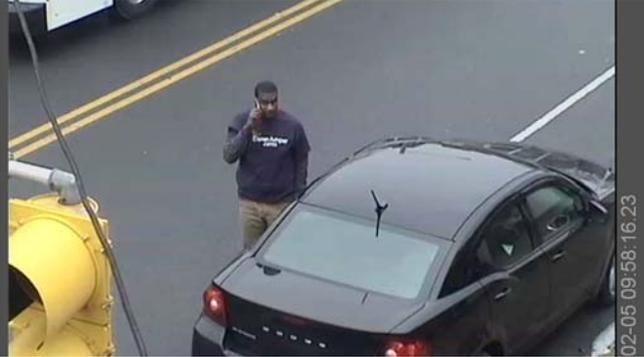
Sample No.	Location/ (OIT ID)	EisnerAmper's Observation 2/5/2013	Conditions/Comments	OIT Status (2/12/2013)	Image
7	Chew & Washington Lane (14-008)	Functioning Camera	<ul style="list-style-type: none"> <li>• very clear 360 degree views with no zoom</li> <li>• some dome issues, scratches</li> <li>• zoom after real-time is heavily pixilated and unreadable</li> </ul>	Working/ Visual Inspection

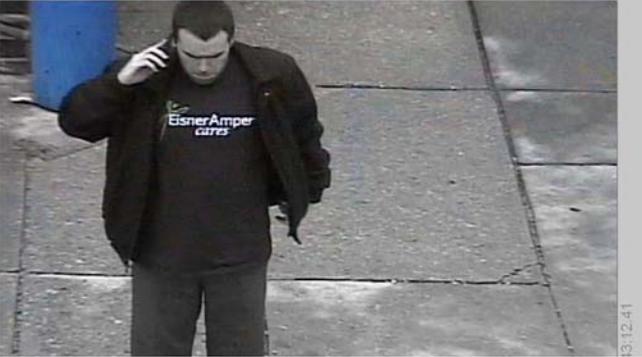
Sample No.	Location/ (OIT ID)	EisnerAmper's Observation 2/5/2013	Conditions/Comments	OIT Status (2/12/2013)	Image
9	Broad & Jefferson (23-009)	Functioning Camera	<ul style="list-style-type: none"> <li>• close zoom at ATM provides a very clear picture</li> <li>• across the street from the ATM, without zoom, cannot see lettering and face is blurry</li> <li>• zoom of one view partially obstructed by traffic light</li> </ul>	Working/ Visual Inspection

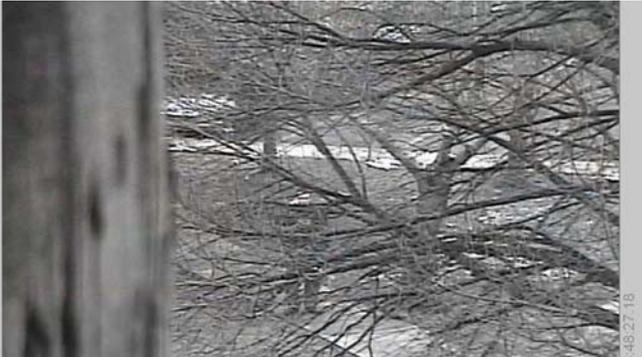
10	15 <sup>th</sup> & Jefferson (23-005)	Problems with Camera	<ul style="list-style-type: none"> <li>• problems with pan, tilt and zoom control</li> <li>• at 22-25', decent image without zoom, face a little blurry and cannot read shirt lettering</li> <li>• one view of camera is obstructed by tree branches</li> <li>• one view of camera shows pink screen (no image)</li> </ul>	Working/ Visual Inspection

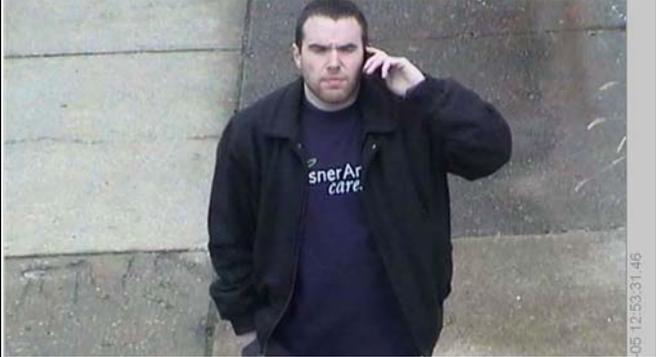
Sample No.	Location/ (OIT ID)	EisnerAmper's Observation 2/5/2013	Conditions/Comments	OIT Status (2/12/2013)	Image
11	18 <sup>th</sup> & Master (23-003)	Functioning Camera	<ul style="list-style-type: none"> <li>• overall image without zoom is clear but some blurriness of facial features and shirt lettering</li> <li>• camera's zoom is very good, very clear</li> <li>• one view of camera is obstructed by telephone pole</li> </ul>	Working/ Visual Inspection

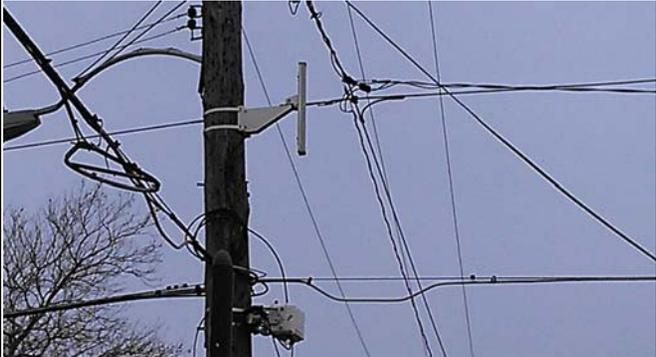
12	Penn & Pratt St. (15-021)	No Image Displayed	<ul style="list-style-type: none"> <li>• no camera present at location, only mounting equipment</li> </ul>	Not Working/ Tech Suggest to Run Fiber to the Camera

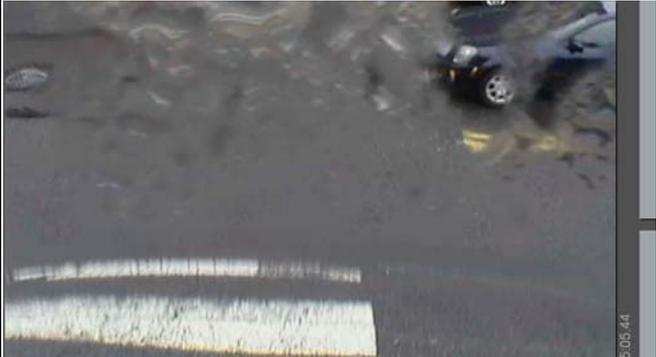
16	Chelton & Knox (14-015)	Problems with Camera	<ul style="list-style-type: none"> <li>• water in the dome</li> <li>• big blob of brown debris on lens</li> <li>• cannot see image of individual across the street from camera without zoom</li> <li>• zoom was hard to control</li> </ul>	Working/ Visual Inspection; Dome needs to be cleaned

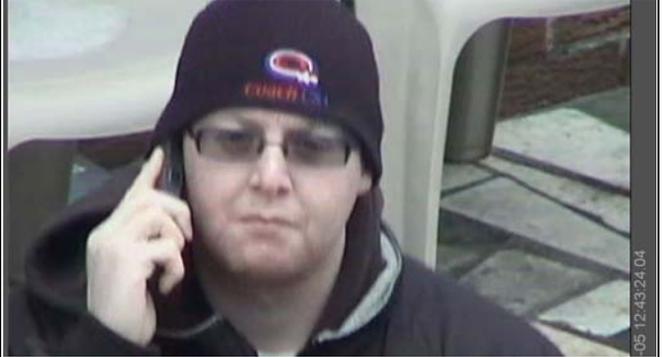
Sample No.	Location/ (OIT ID)	EisnerAmper's Observation 2/5/2013	Conditions/Comments	OIT Status (2/12/2013)	Image
21	600 Tasker St. (04-010)	Functioning Camera	<ul style="list-style-type: none"> <li>• 20-25' with zoom lettering is visible and facial features are clearer</li> <li>• view across the street, face is grainy and details are not sharp</li> <li>• 60'-70' across street with zoom is blurry</li> </ul>	Working/ Visual Inspection

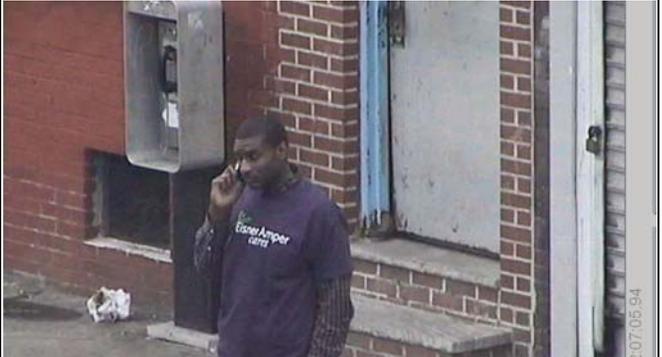
22	5 <sup>th</sup> & Rockland (35-014)	Functioning Camera	<ul style="list-style-type: none"> <li>• image and shirt lettering clear with zoom</li> <li>• one view partially obstructed by pole;</li> <li>• moving vehicles and moving pedestrians display jagged edges</li> </ul>	Working/ Visual Inspection

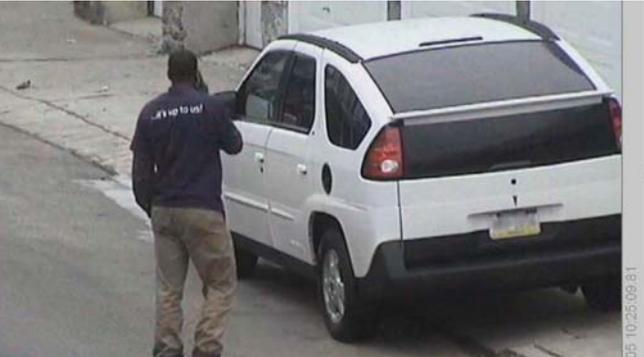
24	Chew & Pleasant (14-019)	Functioning Camera	<ul style="list-style-type: none"> <li>clear image of individual across the street with zoom;</li> <li>without zoom, cannot tell if individual is M/F, B/W</li> </ul>	Working/ Visual Inspection

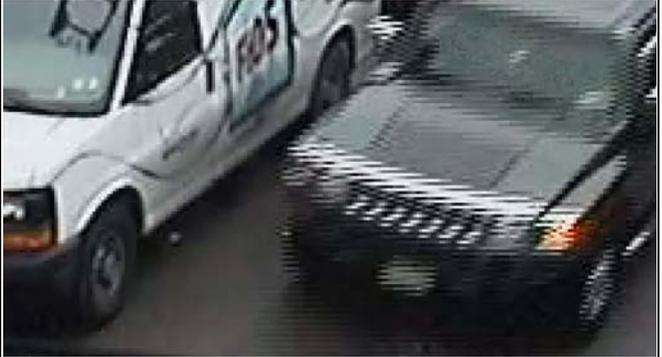
Sample No.	Location/ (OIT ID)	EisnerAmper's Observation 2/5/2013	Conditions/Comments	OIT Status (2/12/2013)	Image
25	18 <sup>th</sup> & Wingohocking St. (35-004)	Functioning Camera	<ul style="list-style-type: none"> <li>• zoom shows clear image, shirt lettering slightly blurred but readable</li> <li>• soft focus on all images</li> <li>• blurred effect on image in motion</li> </ul>	Working/ Visual Inspection

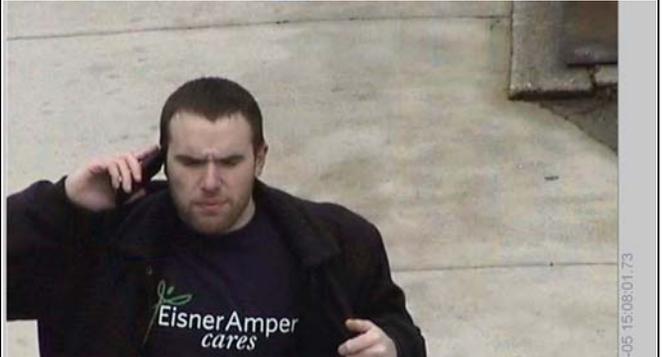
26	Carlisle & York St. (22-024)	Functioning Camera	<ul style="list-style-type: none"> <li>• looking across the street with zoom at 25', lettering on shirt and face very clear</li> <li>• without zoom, cannot tell if person across the street is B/W, M/F</li> <li>• at 100-110', with zoom image is blurry, cannot make out lettering or facial features</li> </ul>	Working/ Visual Inspection

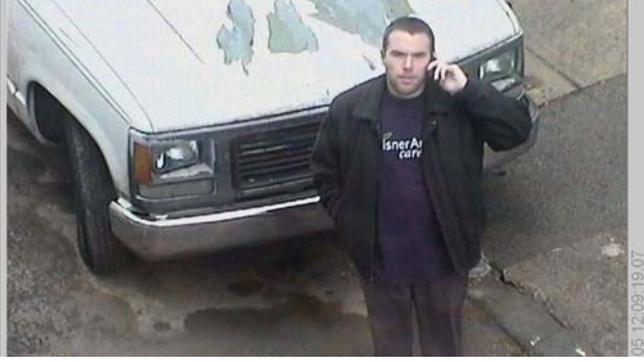
Sample No.	Location/ (OIT ID)	EisnerAmper's Observation 2/5/2013	Conditions/Comments	OIT Status (2/12/2013)	Image
27	900 Leland St. (09-009)	Functioning Camera	<ul style="list-style-type: none"> <li>blurred motion, no sharp images without zoom</li> <li>very clear facial features and t-shirt lettering with zoom at 35'</li> </ul>	Working/ Visual Inspection

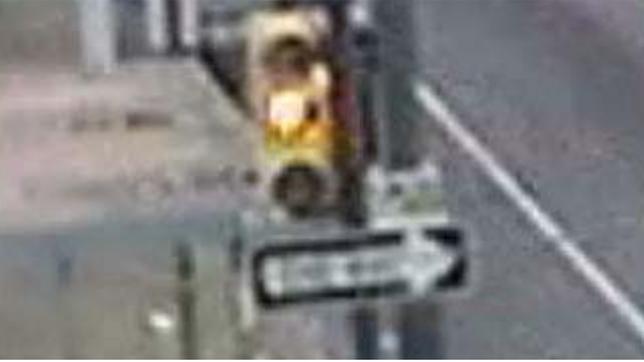
28	12 <sup>th</sup> & Girard Ave (23-037)	Problems with Camera	<ul style="list-style-type: none"> <li>looks like there is a film over images</li> <li>failure of pan, tilt and zoom control</li> <li>no zoom images of entrance to drug store are fairly clear</li> <li>cannot read one-way sign 20' away</li> <li>cannot read letters on sign directly under camera 12-15' away</li> </ul>	Working/ Visual Inspection

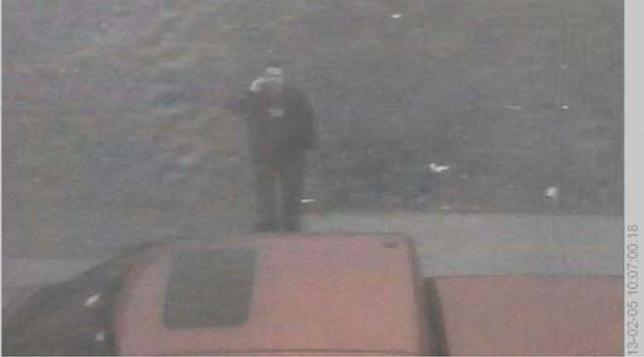
Sample No.	Location/ (OIT ID)	EisnerAmper's Observation 2/5/2013	Conditions/Comments	OIT Status (2/12/2013)	Image
29	4900 Griscom St. (15-009)	Problems with Camera	<ul style="list-style-type: none"> <li>• water in camera dome</li> <li>• condensation on lens</li> <li>• at 60' can see lettering on shirt, but facial features not clear</li> <li>• 360 degree not helpful due to height of camera at cable level, captures poles and cables</li> <li>• blurred zoom at 100' by emergency room entrance but license plates are legible</li> </ul>	Working/ Visual Inspection

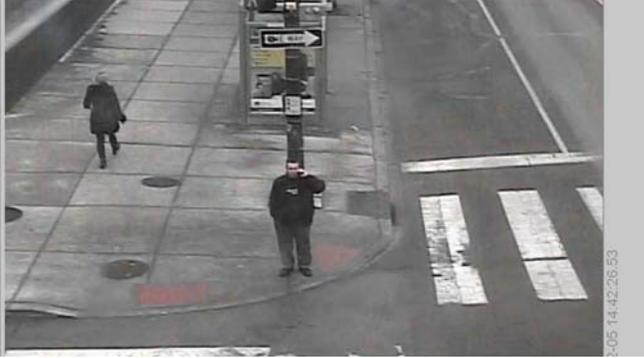
23-011	DRT/BNW: During EA’s 2/5/2013 observation it was noted that the color was off for most views, i.e., mostly black and white with spotty color (yellows and oranges). Some views (especially noticeable during the auto tour) suggested possible film on the dome; North view in particular appeared filmy/dirty. EA’s follow-up on 2/13/2013 found all views to be filmy with faces distorted and no discernible facial features. PPD no longer had PTZ capability.
23-035	BNW: During EA’s 2/5/2013 observation it was noted that the color was off at every camera angle, i.e. black & white with spotty colors (red & blue). At 20-25’ without zoom the camera rendered a grainy image with only black, white and red. EA’s follow-up on 2/13/2013 noted that the color remained spotty.

30	Broad and Montgomery (23-011)	Problems with Camera	<ul style="list-style-type: none"> <li>• dirt, soil on dome</li> <li>• image across the street is blurred but useable without zoom</li> <li>• 75-80' people are blurred, hard to tell if M/F, B/W</li> <li>• color is off, mostly black and white with spotty color for most views</li> </ul>	Working/ Visual Inspection; camera reset on 1-8-13

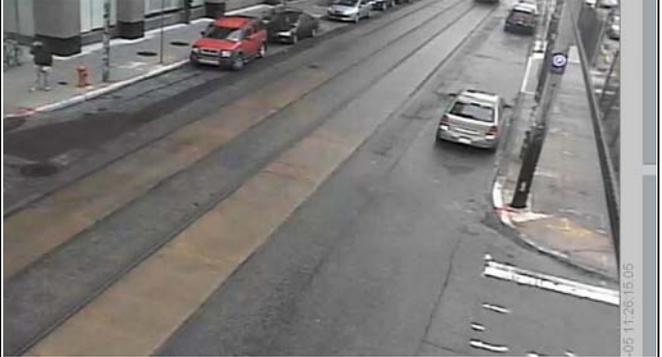
Sample No.	Location/ (OIT ID)	EisnerAmper's Observation 2/5/2013	Conditions/Comments	OIT Status (2/12/2013)	Image
31	36 <sup>th</sup> & Filbert (16-002)	Problems with Camera	<ul style="list-style-type: none"> <li>intermittent pan, tilt and zoom control and strange angles</li> <li>image is slightly blurred, unable to read license plates with no zoom</li> </ul>	Working/ Visual Inspection
