OFFICE OF THE CONTROLLER

Review of Public Pool Chair Lifts and Facilities

Department of Parks & Recreation

July 2025

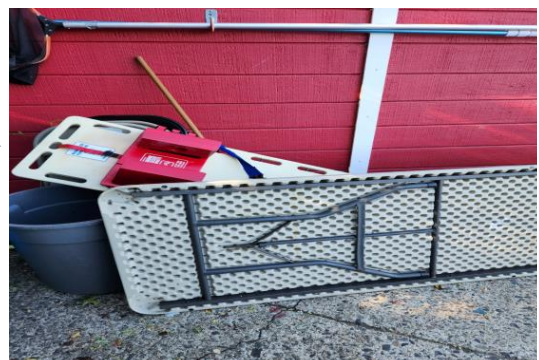
Lifesaving equipment, such as rescue rings, backboards, and medical supplies, should be stored in a secure location that is readily accessible by the lifeguards or other pool staff. This would help minimize the time used to search for critical care supplies and ensure a timely rescue response when needed. Investigators found lifesaving equipment was accessible in eleven of the twelve pool sites we visited. However, at the Fox Chase pool, a backboard was on the side of a storage shed alongside a table blocking its access. See [PHOTOGRAPH 1](#) below. Before leaving the Fox Chase pool, investigators notified the lifeguards that the backboard needed to be stored in a secure, readily accessible location.

PHOTOGRAPH 1: FOX CHASE POOL -
Medical Rescue Backboard found beside the maintenance shed, alongside a trash can and folding table.

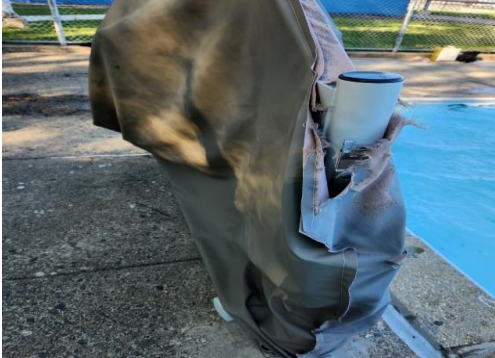
PHOTOGRAPH 2: FOX CHASE POOL –
Chair lift appears inoperable since it is not available for everyday use. The cover is weather-beaten and torn.

Fox Chase- Battery replaced & chair lift operating

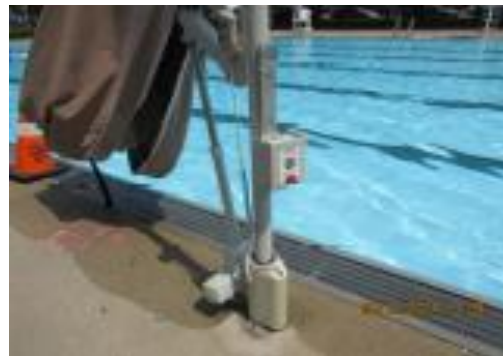
PHOTOGRAPH 3: MANDER POOL –
Chair lift battery was missing.

Mander- Battery replaced & chair lift operating

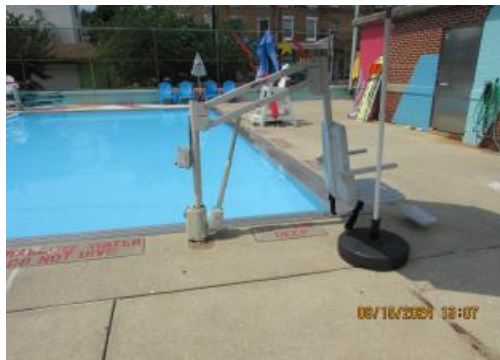
PHOTOGRAPH 4: PENROSE POOL –
Chair lift battery was missing.

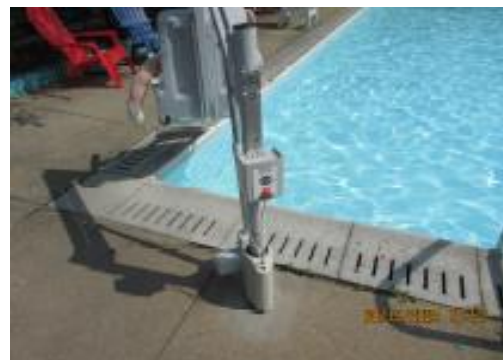
PHOTOGRAPH 5: PLEASANT POOL –
Chair lift was inoperable.

Pleasant- Battery replaced & chair lift operating

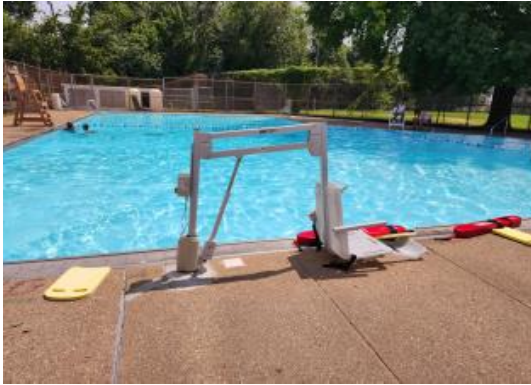
PHOTOGRAPH 6: SIMPSON POOL –
Chair lift was inoperable.

Simpson- Currently chair lift works, but not properly; Skilled trades is working to resolve

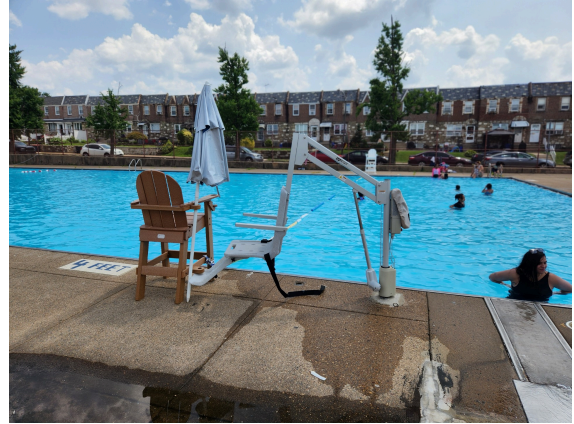
During our August 2024 on-site visits, investigators found that four of the twelve new chair lifts were not operational. For example, at the Vogt Pool, investigators found that the visitors could not use the chair lift because a mechanical problem prevented it from moving left to right to accommodate those trying to sit on it, or pool staff trying to direct it towards the pool. Additionally, batteries for two other chair lifts were missing so investigators could not determine if the lifts were functional. Both conditions at the six sites are displayed in [PHOTOGRAPHS 2 through 7](#) below.

PHOTOGRAPH 7: VOGT POOL – While the chair lift can move up and down, it cannot swing from left to right, which prevents visitors from using it and lifeguards from properly and safely operating it.

Vogt- Currently chair lift works, but not properly; Skilled trades is working to rectify the problem

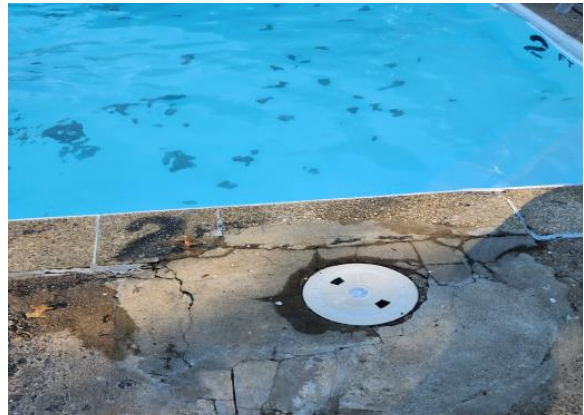
- **Fox Chase Pool** – The pool water, while clear, contained decaying leaves that had gathered at the bottom. Furthermore, areas around the pool showed evidence of cracking concrete and patched repair work that creates a tripping hazard. Low-hanging electrical wires were also observed behind a building that could be accessible to wandering children. See **PHOTOGRAPHS 8, 9 and 10** on page 6.

PHOTOGRAPH 8: FOX CHASE POOL –
Cracks observed in the concrete next to the shallow end of the pool. Additionally, decaying leaves were at the bottom of the pool.

- Repair broken cement surrounding the pool areas;
- Repair broken fences, as needed; and
- Repair and repaint spray grounds, where needed.

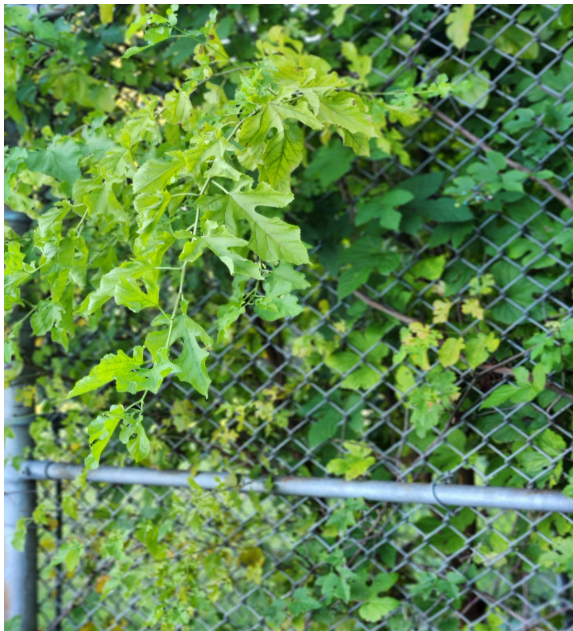
PHOTOGRAPH 9: FOX CHASE POOL –
Vegetation was observed growing over the fence.

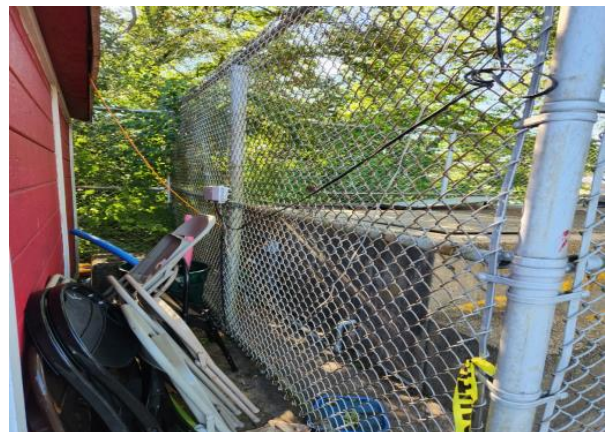
PHOTOGRAPH 10: FOX CHASE POOL –
Low-hanging electrical wires behind building could be accessible to children.

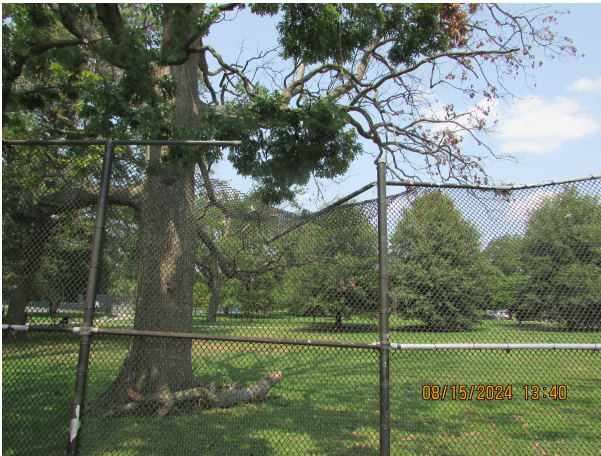
PHOTOGRAPH 11: MANDER POOL –

- **Mander Pool** – A fallen tree limb damaged the fence surrounding the pool property and had not yet been repaired. While creating a safety hazard for anyone trying to climb the fence, it also creates a liability for the city since the pool's perimeters are not adequately secured from intruders. Investigators also identified cracks in the concrete and breaks in the wooden planks surrounding the pool that creates tripping hazards where staff and visitors regularly walk. See **PHOTOGRAPHS 11, 12 and 13** on page 7.

Fencing, surrounding the pool area, was damaged by a falling tree limb, but not repaired timely

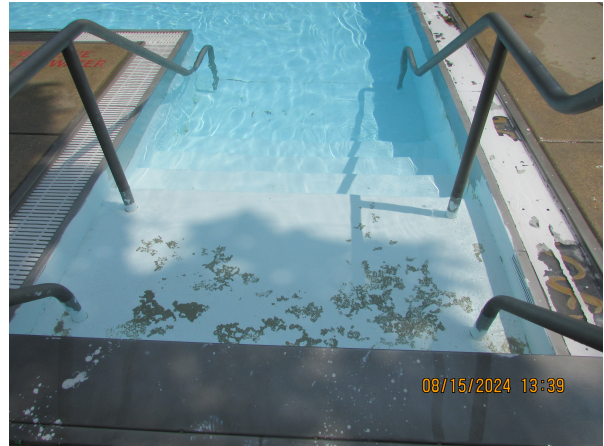
PHOTOGRAPH 12: MANDER POOL –

Paint chipping on the steps of the pool, which creates a slipping hazard

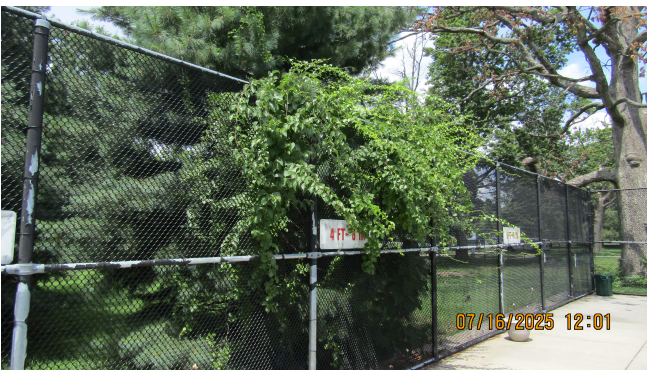
PHOTOGRAPH 13: MANDER POOL –

Vegetation grown over the fence past an acceptable length.

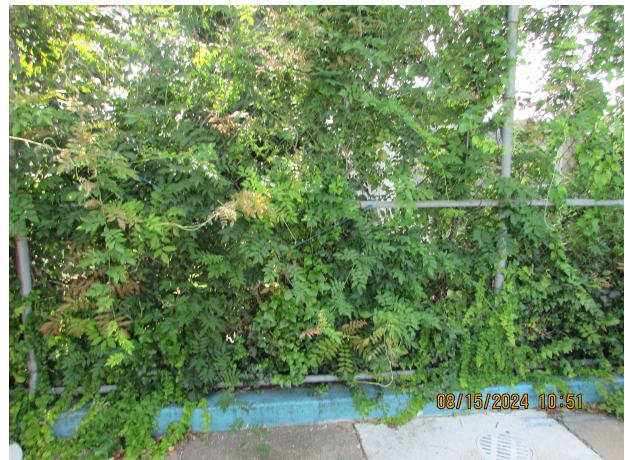
PHOTOGRAPH 14: PLEASANT POOL –

- **Pleasant Pool** – Investigators observed significant amount of overgrown vegetation in areas around the pool. See **PHOTOGRAPH 14** below.

Vegetation grown over the fence past an acceptable length.

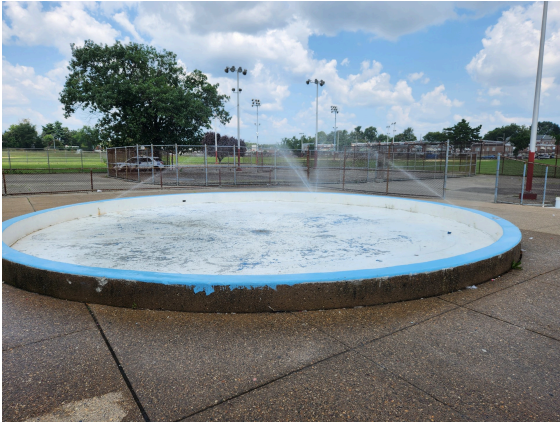
- [Vogt Pool and Spray Ground](#) – There were cracks in the concrete around the pool area. The ledge around the spray ground showed evidence of damaged concrete while the interior of the spray area exhibited chipping paint. See [PHOTOGRAPHS 15](#) and [16](#) below.

PHOTOGRAPH 15: VOGT POOL –
Spray grounds show evidence of cracking concrete on the exterior ledge and chipping paint on the interior of the spray area.

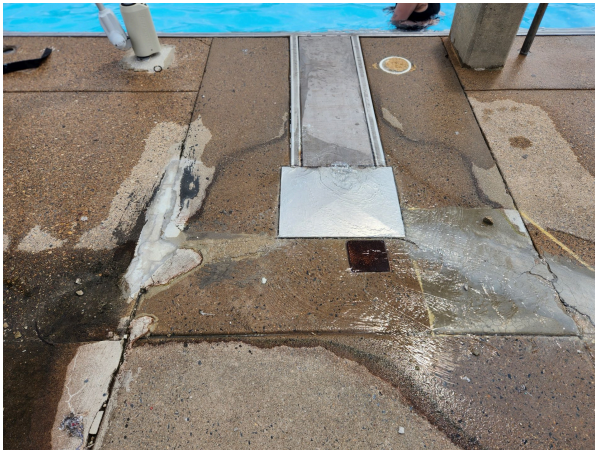
PHOTOGRAPH 16: VOGT POOL –
Filter not working properly, shows cracks in the concrete caused by blocked drains.
