**Review of Public Pool Chair Lifts and Facilities**

**Department of Parks & Recreation**

**April 2025**

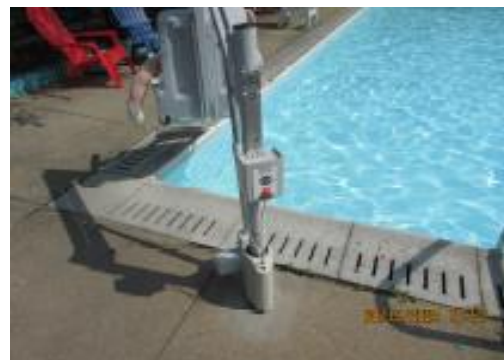
**PHOTOGRAPH 5: PLEASANT POOL –**  
Chair lift was inoperable.

- Ensure that all pool chair lifts are functioning properly so everyone can enjoy the facilities;
- Locate missing batteries and ensure that they are installed in the chair lifts at the beginning of each day. Likewise, the batteries should be removed and securely stored at the end of each day.
- Provide pool staff and lifeguards with annual refresher training on how to operate the chair lifts;
- Vacuum the pools each day to remove decaying leaves that could block drains and cause slipping hazards;

Pleasant- Battery replaced & chair lift operating

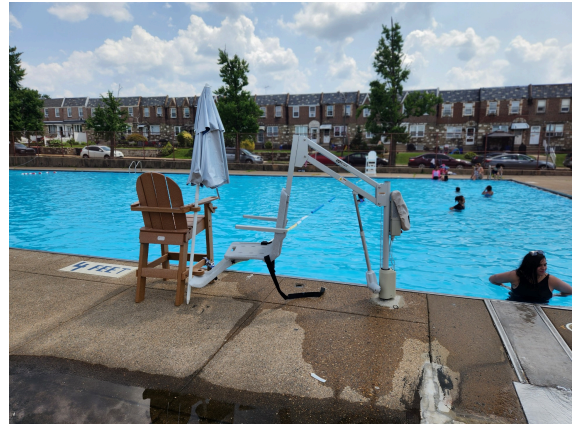
During our August 2024 on-site visits, investigators found that four of the twelve new chair lifts were not operational. For example, at the Vogt Pool, investigators found that the visitors could not use the chair lift because a mechanical problem prevented it from moving left to right to accommodate those trying to sit on it, or pool staff trying to direct it towards the pool. Additionally, batteries for two other chair lifts were missing so investigators could not determine if the lifts were functional. Both conditions at the six sites are displayed in [PHOTOGRAPHS 2 through 7](#) below.

**PHOTOGRAPH 7: VOGT POOL –** While the chair lift can move up and down, it cannot swing from left to right, which prevents visitors from using it and lifeguards from properly and safely operating it.

Vogt- Currently chair lift works, but not properly; Skilled trades is working to rectify the problem

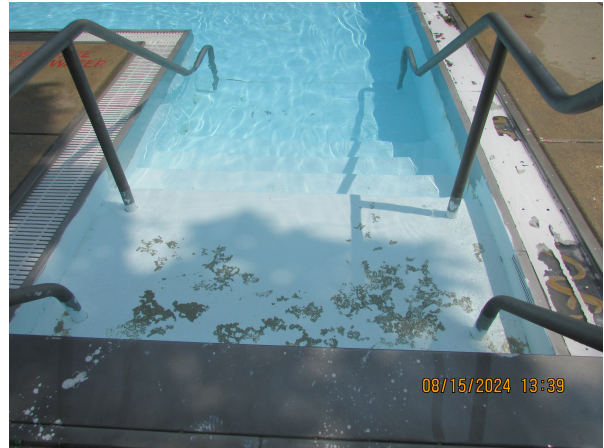
**PHOTOGRAPH 12: MANDER POOL –**

Paint chipping on the steps of the pool, which creates a slipping hazard

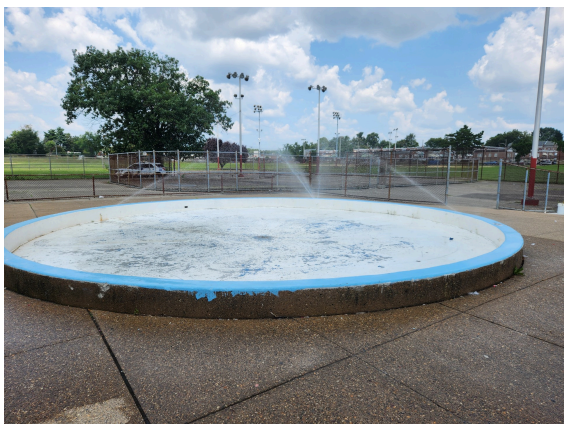
- Vogt Pool and Spray Ground – There were cracks in the concrete around the pool area. The ledge around the spray ground showed evidence of damaged concrete while the interior of the spray area exhibited chipping paint. See [PHOTOGRAPHS 15 and 16](#) below.

**PHOTOGRAPH 15: VOGT POOL –**  
Spray grounds show evidence of cracking concrete on the exterior ledge and chipping paint on the interior of the spray area.

- Repair broken cement surrounding the pool areas;
- Repair broken fences, as needed; and
- Repair and repaint spray grounds, where needed.

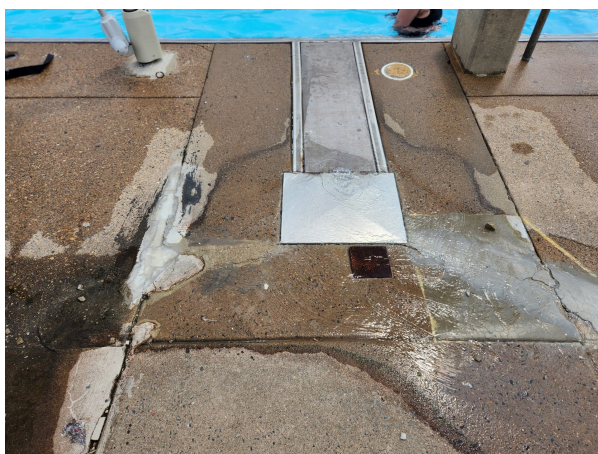
**PHOTOGRAPH 16: VOGT POOL –**  
Filter not working properly, shows cracks in the concrete caused by blocked drains.
